LOOP ROAD SAFETY IMPROVEMENTS PROJECT

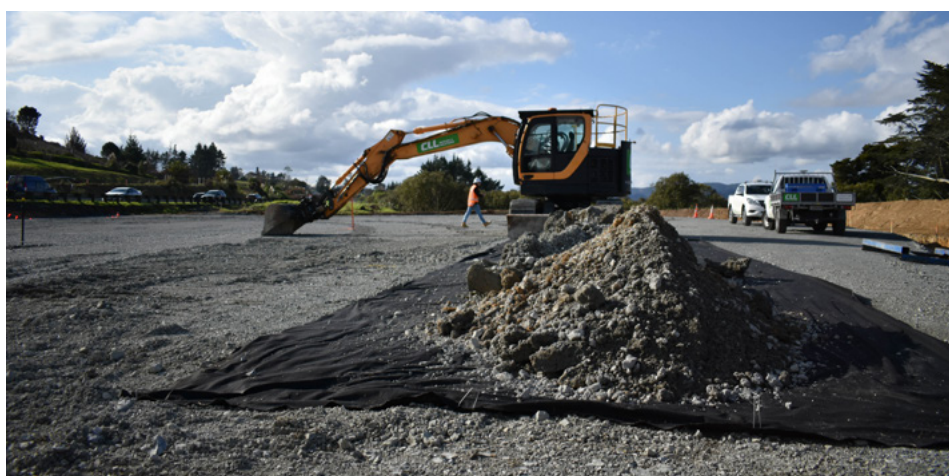
This is the spoils of the soil that stick to the drill bit, as it retreats back up when the concrete is simultaneously injected. This is very minimal excess compared to a normal drilling process due to the rotary displacement of the soil, meaning most of the soil is compacted and remains in the ground.

Concrete piles are currently being installed as part of ground improvement works to future proof the outer edge of the roundabout for additional capacity.

The process is called 'rotary displacement' and involves drilling a 450mm diameter hole into the ground with a feeder tube attached to the drill that then pumps concrete into the hole as the drill bit is being pulled out.

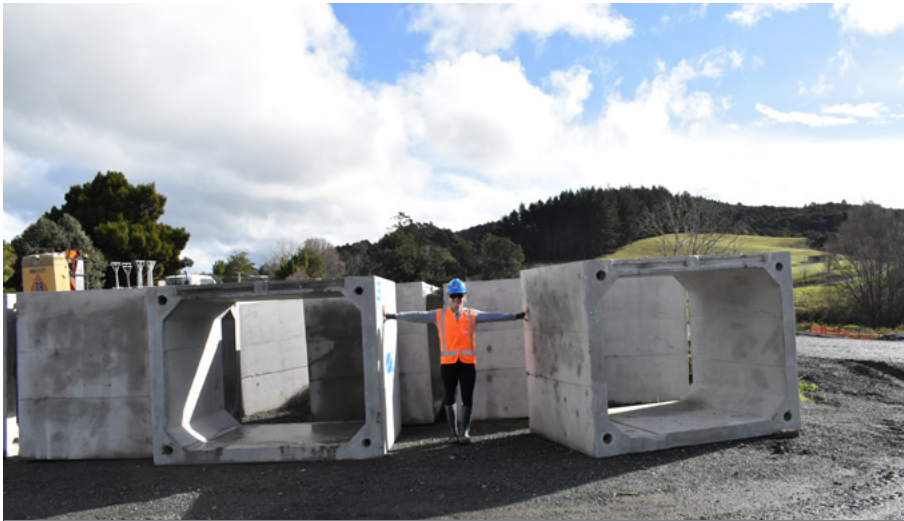
Fulton Hogan's Stakeholder Manager, Mel Norris, stands next to sections of the new concrete box culvert. Each 2m section weighs 4.7 tonne.

The existing concrete culvert under the state highway is not big enough to support the new intersection so 75 metres of new box culvert is being installed.

Sections of the box culvert will be installed on Loop Road (North) up to the existing highway, then traffic will be shifted temporarily to enable the final section across SH1 to be installed.
