TREC Hawke's Bay recovery update

Transport
Rebuild
East Coast

December 2024

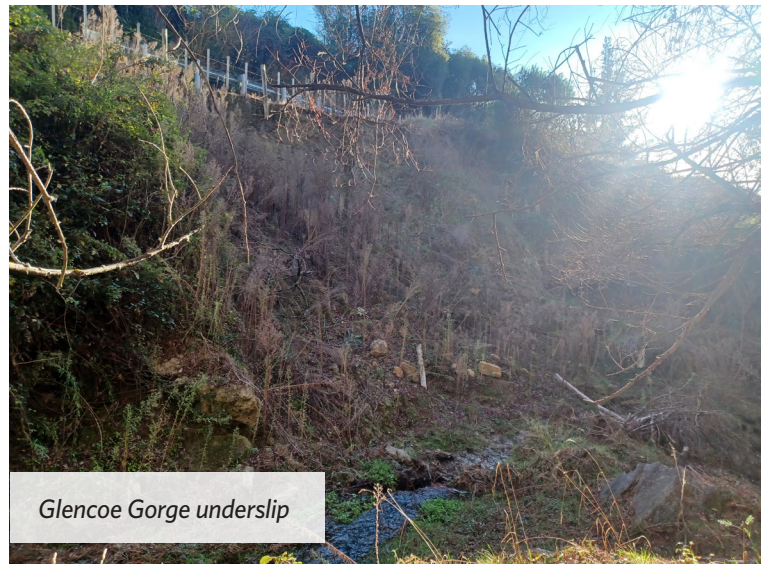
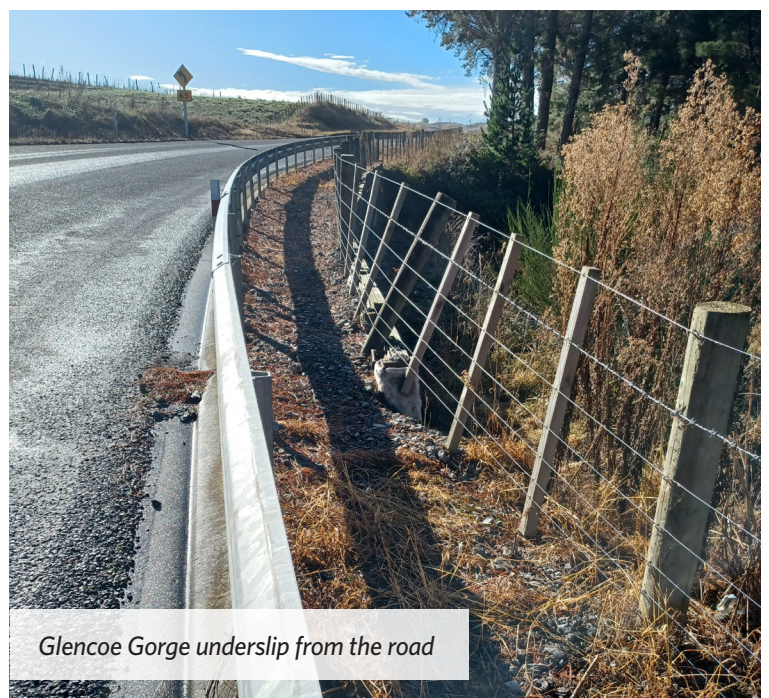
The Glencoe Gorge underslip is around 15m high and 10m wide and has undermined the existing guardrail and farm fence located along SH50.

When there is an underslip on the downhill side of the road it poses a risk to the road above if it isn't addressed. Because underslips are usually out of sight below the road, it can be difficult to see the damage and what's happening to fix it when you're travelling past.

To start the repair, we'll first dig a track down to the bottom of the underslip so the team can access the site and remove the old slip material. There will also be a temporary stream diversion to protect aquatic life.

An EcoReef wall, made from hexagonal blocks filled with material will be constructed to protect against future erosion. The edge of the road surface is then reinstated and new guardrail is installed.

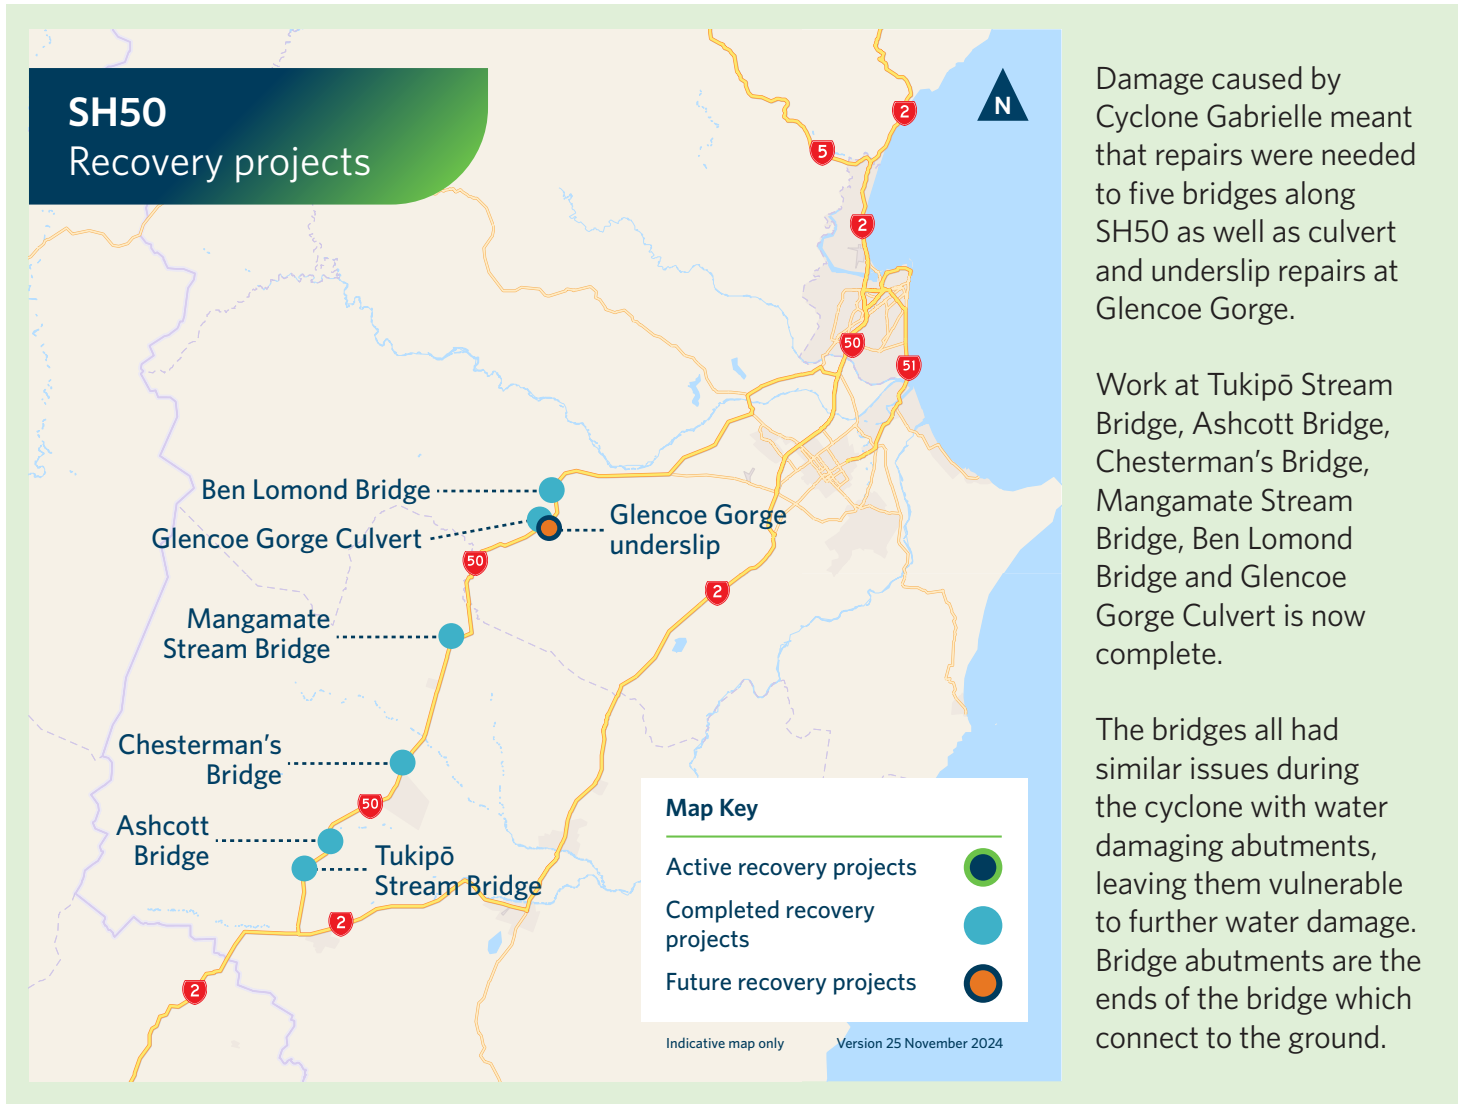
Recovery work on SH50

Damage caused by Cyclone Gabrielle meant that repairs were needed to five bridges along SH50 as well as culvert and underslip repairs at Glencoe Gorge.

The bridges all had similar issues during the cyclone with water damaging abutments, leaving them vulnerable to further water damage. Bridge abutments are the ends of the bridge which connect to the ground.

Work at Tukipō Stream Bridge, Ashcott Bridge, Chesterman's Bridge, Mangamate Stream Bridge, Ben Lomond Bridge and Glencoe Gorge Culvert is now complete.

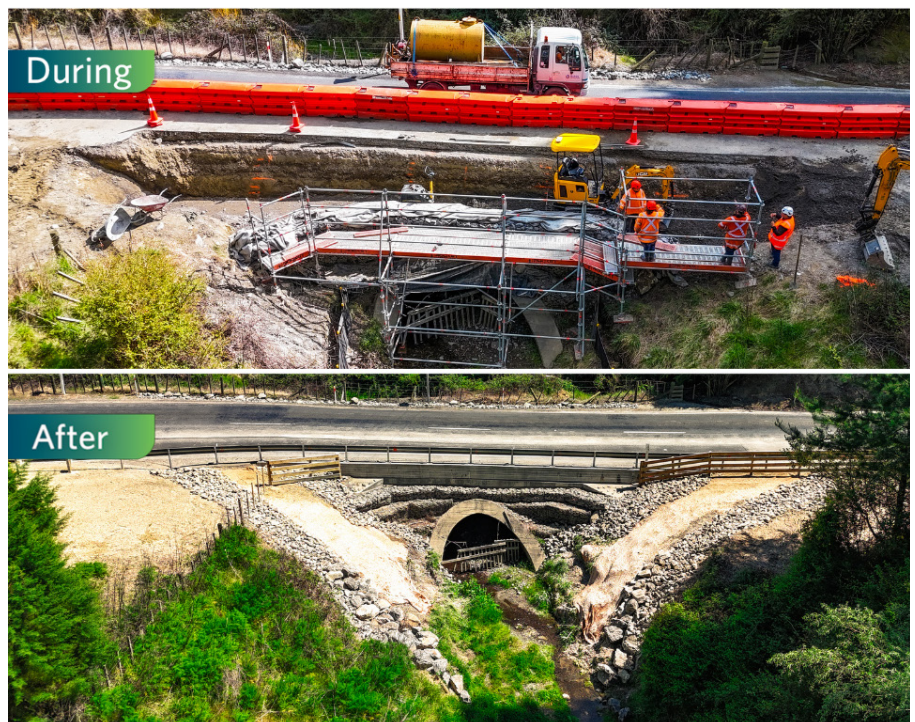
Glencoe Gorge Culvert

Recovery works are complete at Glencoe Gorge, five minutes south of Maraekākaho, where heavy rain caused significant damage to the Glencoe Culvert and retaining wall. The damage caused water to enter the culvert's foundation, increasing the potential for erosion.

The existing retaining wall had buckled over due to the tension from heavy rain causing cracks. Crews excavated the roadside to remove and replace the existing walls and then rebuilt the road above.

The damaged culvert was repaired and strengthened by raising it to the road level. This will improve drainage and better manage water surface runoff.

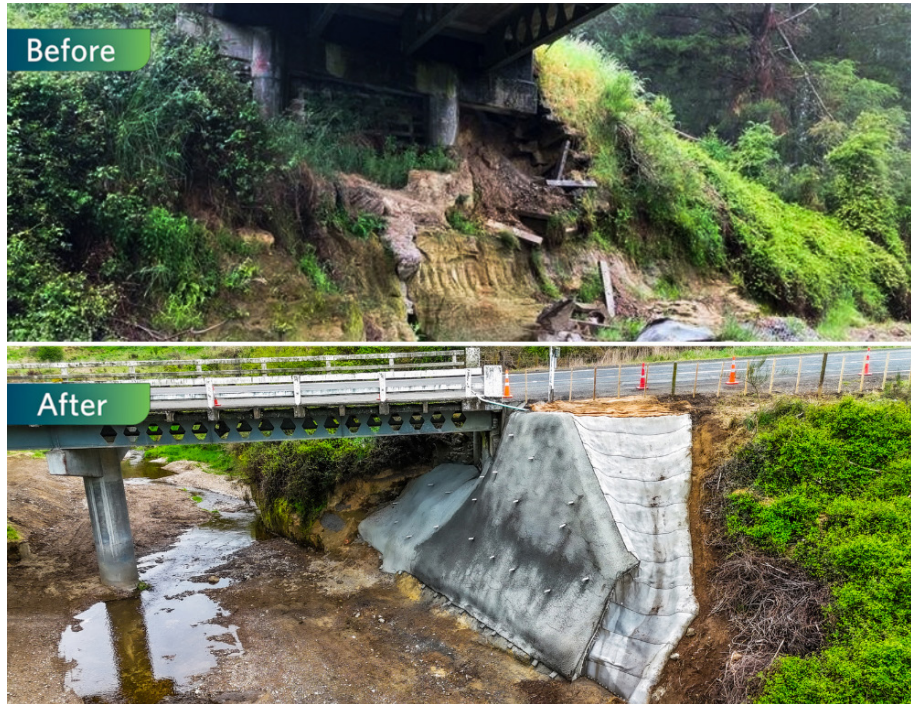
Mangamate Stream Bridge

During Cyclone Gabrielle, floodwaters scoured (eroded) away part of the bank underneath Mangamate Stream Bridge, compromising the bridge abutment which connects it to the land. The road shoulder slumped away, and the road was down to a single lane.

The bridge abutment was reasonably challenging to repair during the winter with water levels going up and down. Repairs were focused around increasing ground stability to provide resilience for the road whenever the ground becomes waterlogged.

Specialist crews installed 26 ground anchors to stabilise the bank and support the bridge and road above. The team drilled holes up to 12m deep, placing the steel anchors into the holes and grouting them into place.

Ground anchors are long steel rods which give the ground and road extra stability. They are a crucial part of the recovery work.

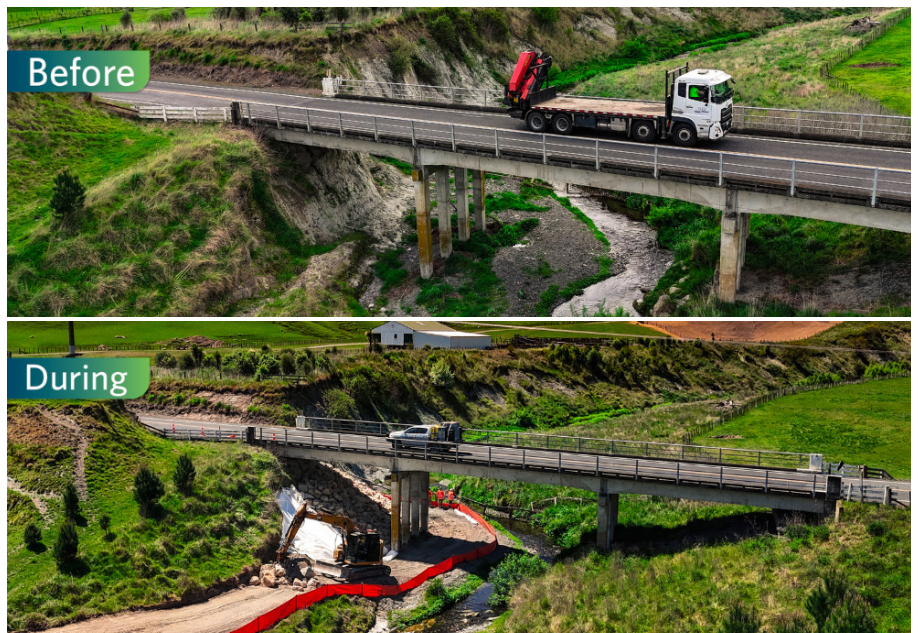
Ben Lomond Bridge

The bridge, built in 1973 across the Maraekākaho river, had intense flows during Cyclone Gabrielle. These flows and additional storms wore away the riverbanks opposite the northern pier, potentially weakening the ends of the bridge where it rejoins the hillside and the structural integrity of the bridge.

To prevent erosion we installed geofabric along with 400 tonnes of riprap (large rocks) on top of this.

These large riprap rocks placed along the edge act as a shield. They absorb the force of the water, protecting the soil and keeping the riverbank intact, resulting in protection to the bridge's foundations.
