# 2 Recommended resilience improvements Devil's Elbow Information sheet

## Devil's Elbow on State Highway 2 (SH2) suffered massive damage caused by Cyclone Gabrielle, resulting in road closures.

## The preferred rebuild option represents significant improvements at Devil's Elbow

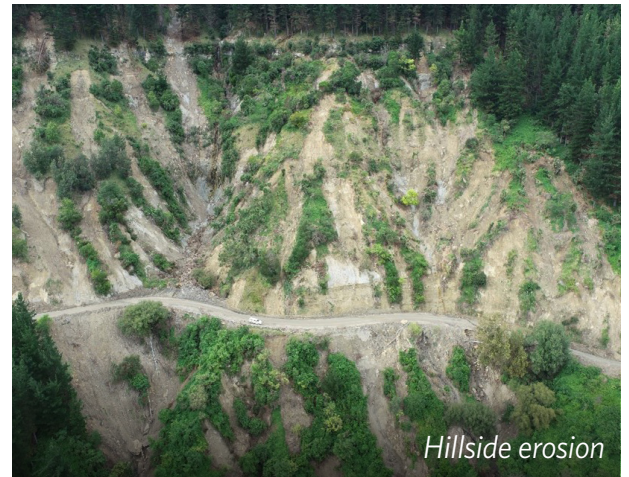
Hillside erosion

Undersized stormwater infrastructure is unable to carry the large volumes of water and debris from the surrounding 660 hectare catchment. This undermines the road and erodes the surrounding hillsides. The existing road is also narrow. When there are slips or rockfall this results in full road closures for maintenance crews to clear the road. There are also safety issues on this winding route and at the sharp bend.

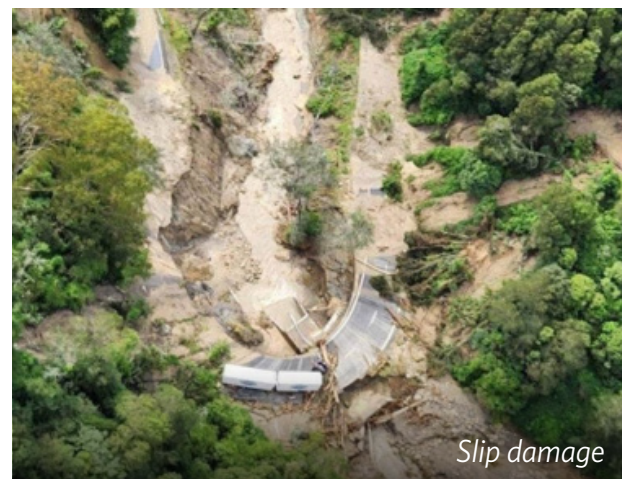
Slip damage

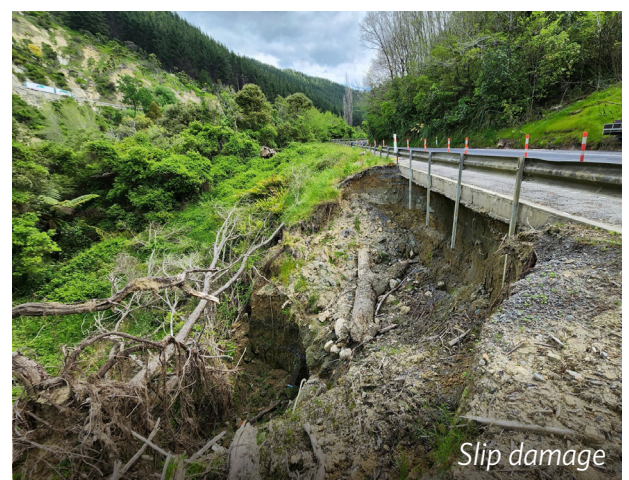
Slip damage

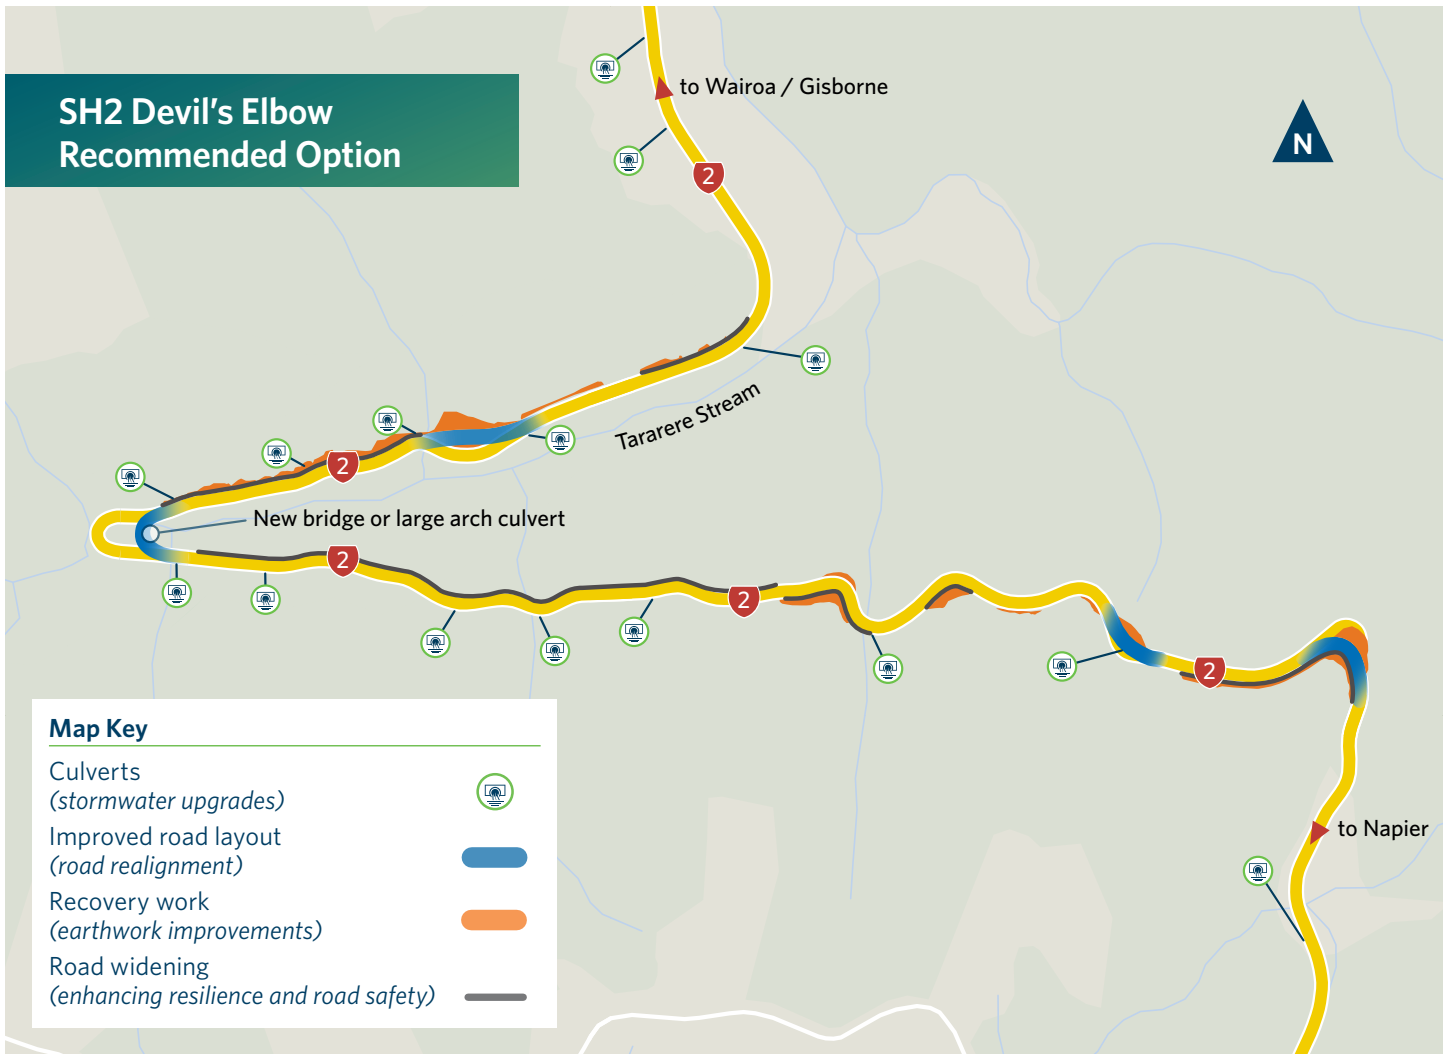
**A new bridge concept**

Easing the sharp bend at Devil's Elbow to improve safety and manage water flows better.

existing highway

new bridge or culvert

Our design for this area includes a new curved bridge or arch culvert, easing the sharp bend at Devil's Elbow to improve safety and manage water flows better.
