# TREC Pānui

## East Coast recovery mahi

TREC Pānui is a monthly newsletter from the [Transport Rebuild East Coast \(TREC\) Alliance](#) updating communities across Te Tairāwhiti (Gisborne) and Te Matau a Māui (Hawke's Bay) about the recovery work on state highways and rail networks impacted by Cyclone Gabrielle.

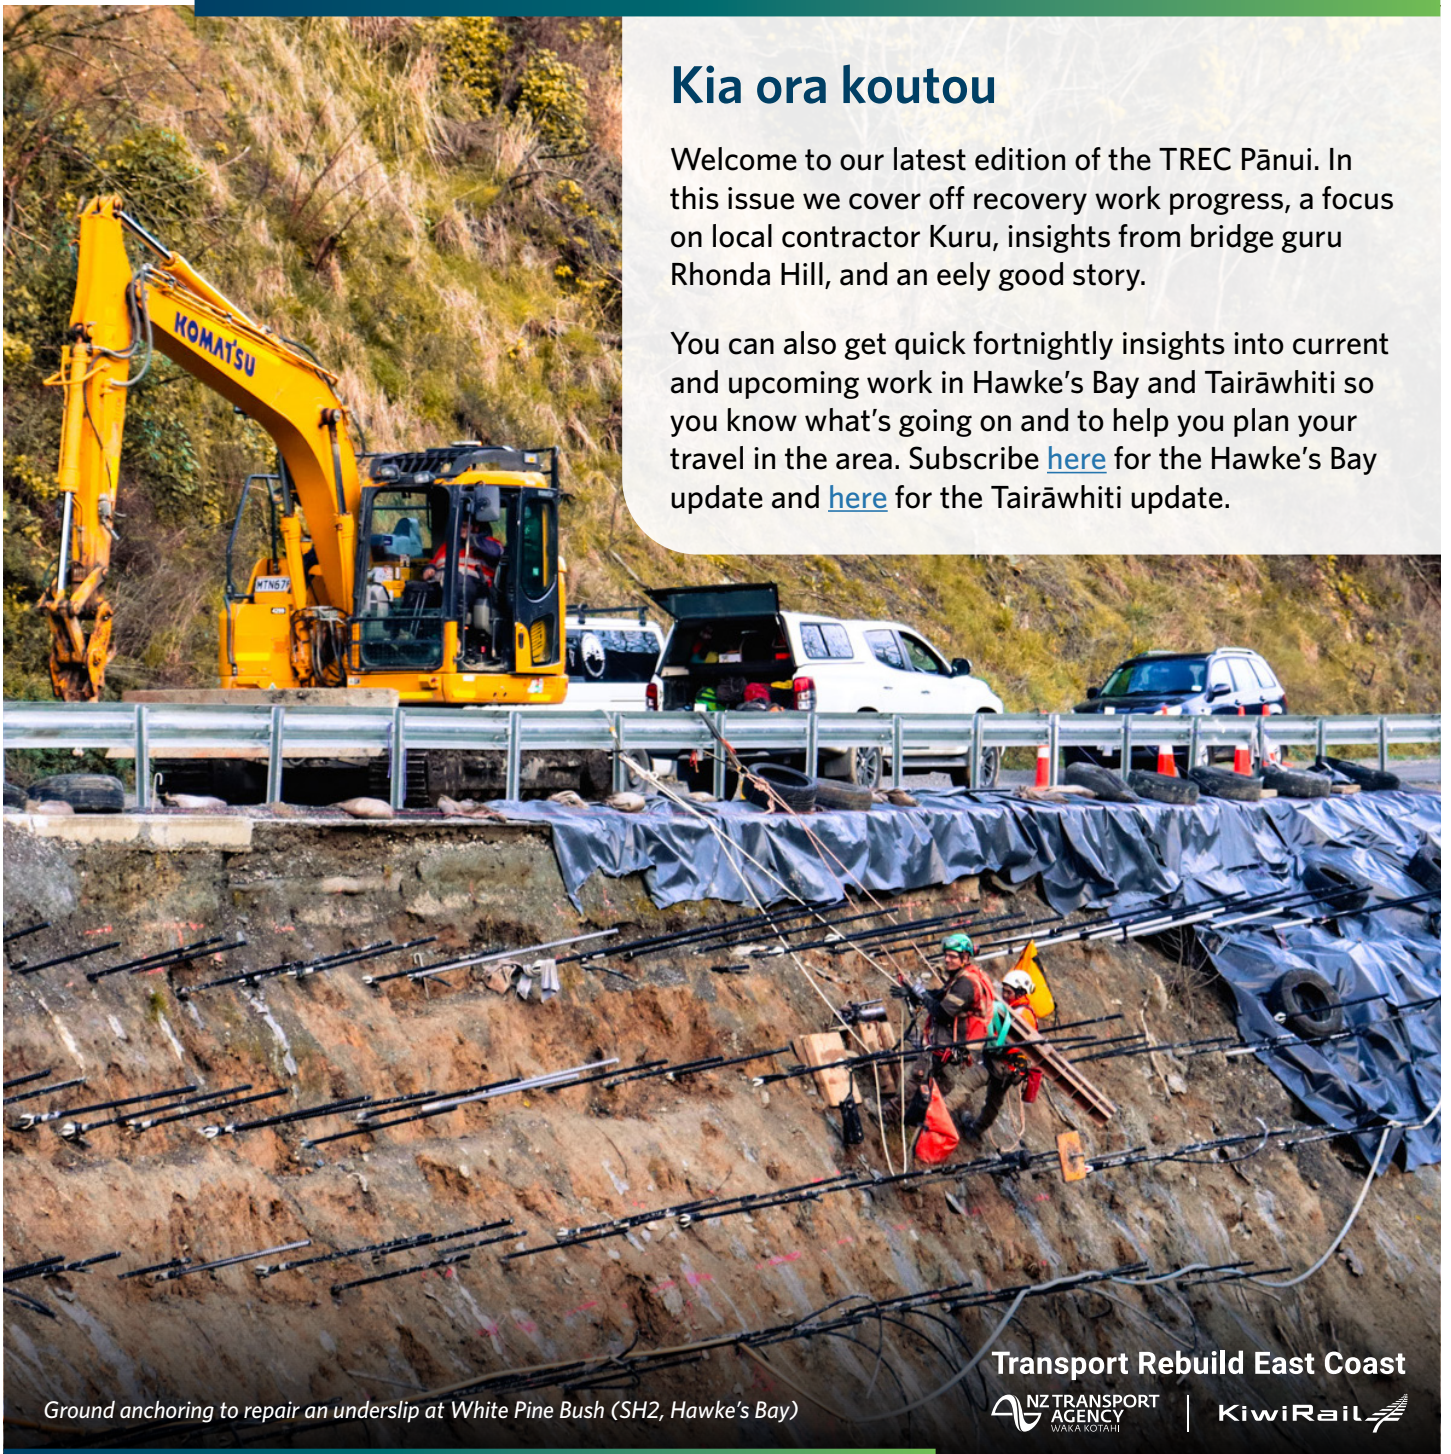
Ground anchoring to repair an underslip at White Pine Bush (SH2, Hawke's Bay)

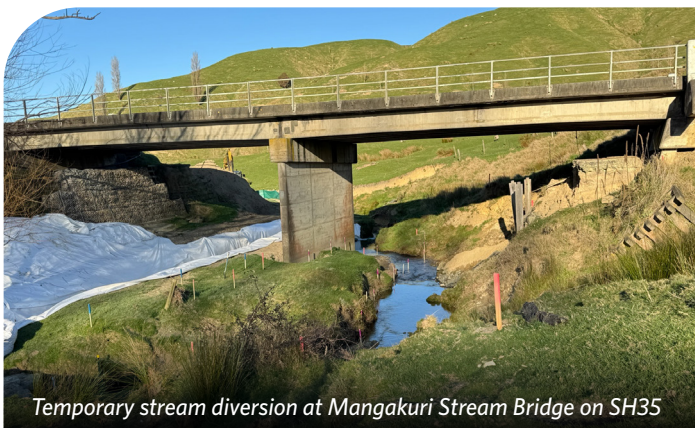
Temporary stream diversion at Mangakuri Stream Bridge on SH35

Repair work has started at Mangakuri Stream Bridge just north of Whangara.

Rock work to strengthen and protect a heavily scoured base beneath the bridge as well as recontouring the southern bridge approach will be underway for the next couple of months.

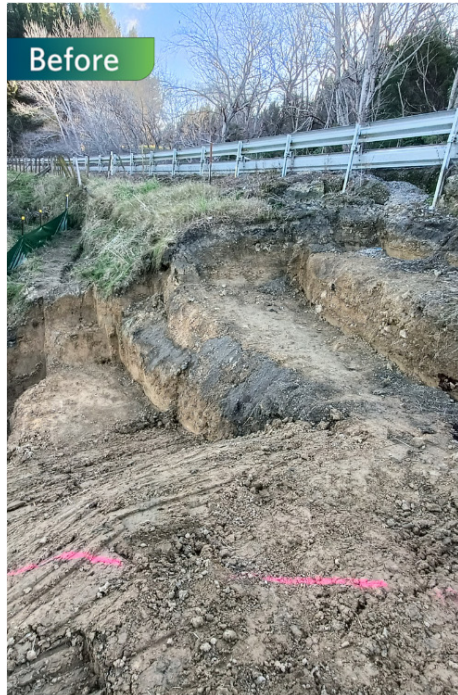
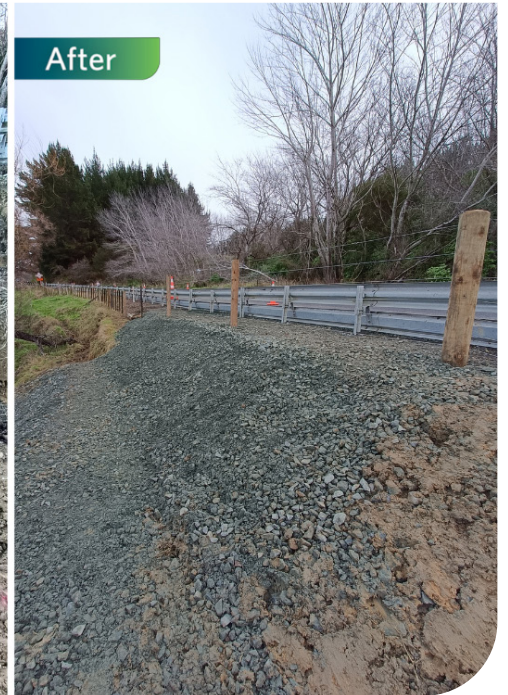
Pictured above is an underslip that has been treated with engineered fill (material) which has then been compacted to strengthen this area against future weather.

Recovery work at Otoko Hill is largely focused on repairing underslips and installing extensive drainage to remove excess water in the surrounding hills.

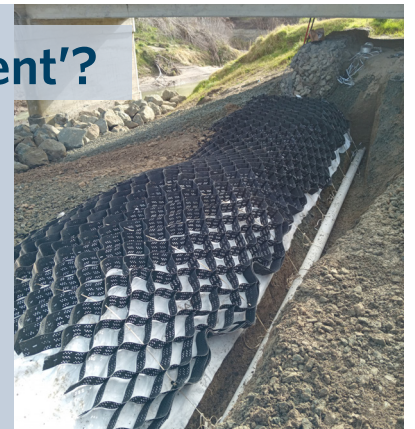
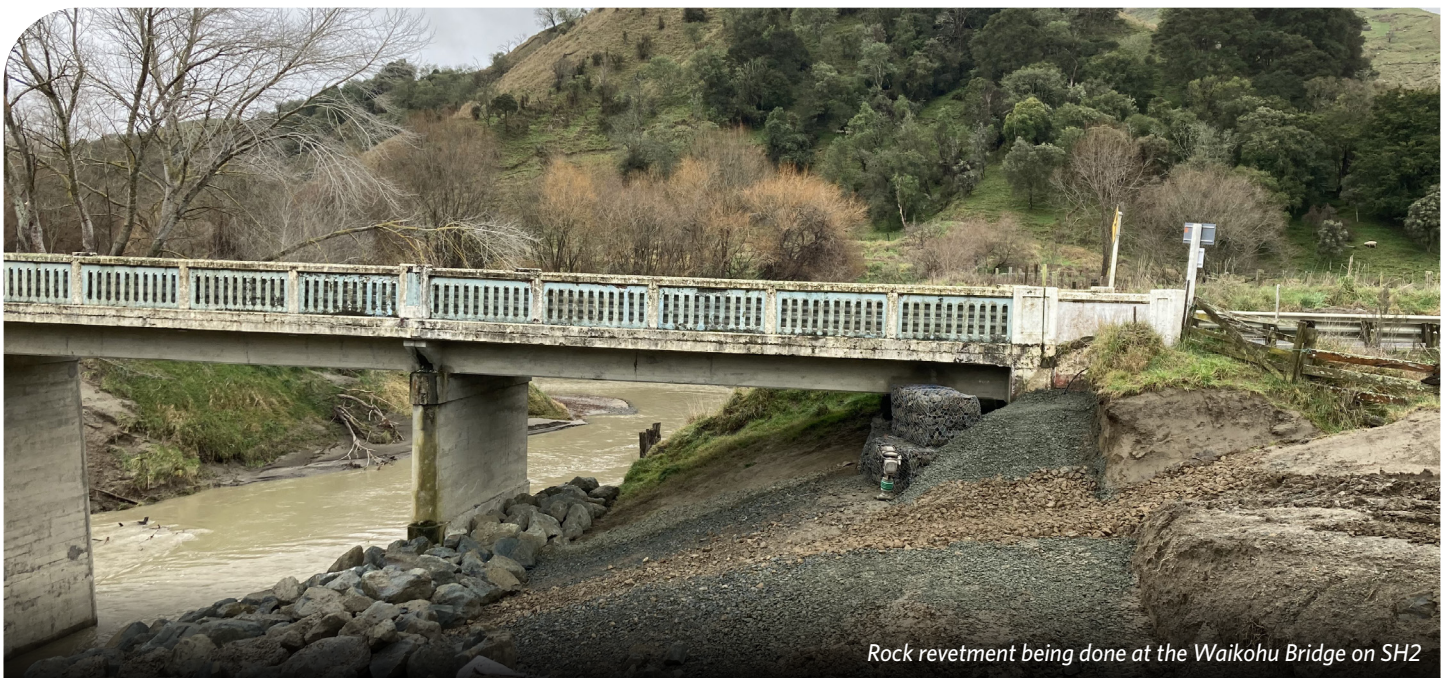
Rock revetment being done at the Waikohu Bridge on SH2

Eight weeks of 'rock revetment' work is complete at SH2 Waikohu Bridge. Approximately 1,100 tonne of 'riprap' was used for this job completed by local contractors Jesse James.

The rocks had been put in place just prior to the late June storm and worked perfectly to protect the riverbank, preventing erosion from the Waikohu River.

Rock revetment is a rock barrier built up to help protect against erosion.

Black woven geogrid is laid down before the riprap (rocks) is placed over the top using a digger bucket. The geogrid helps to grip the rocks and hold them in place.

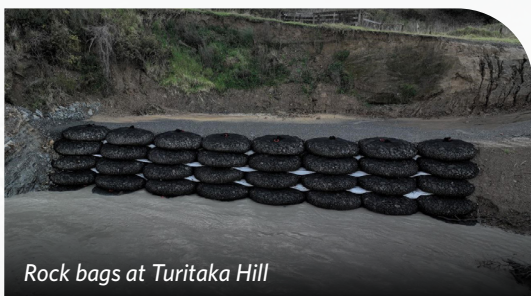
Rock bags at Turitaka Hill

This involved strengthening the 'toe' of the riprap revetment (rock wall) to hold the riverbank wall together to prevent further erosion.

Innovative flexible mesh nets filled with rock or 'riprap' (called rock bags) were used to strengthen the toe. They don't need foundations installed or for the riverbed to be prepared, so are an excellent solution for uneven or sloping surfaces like this site.

Each rock bag spreads to a diameter of roughly two metres and settle into their own seating on the Waiapu riverbed for excellent coverage. The honeycomb layout and being stacked on each other in a staggered pattern also provides stability against the river flow.

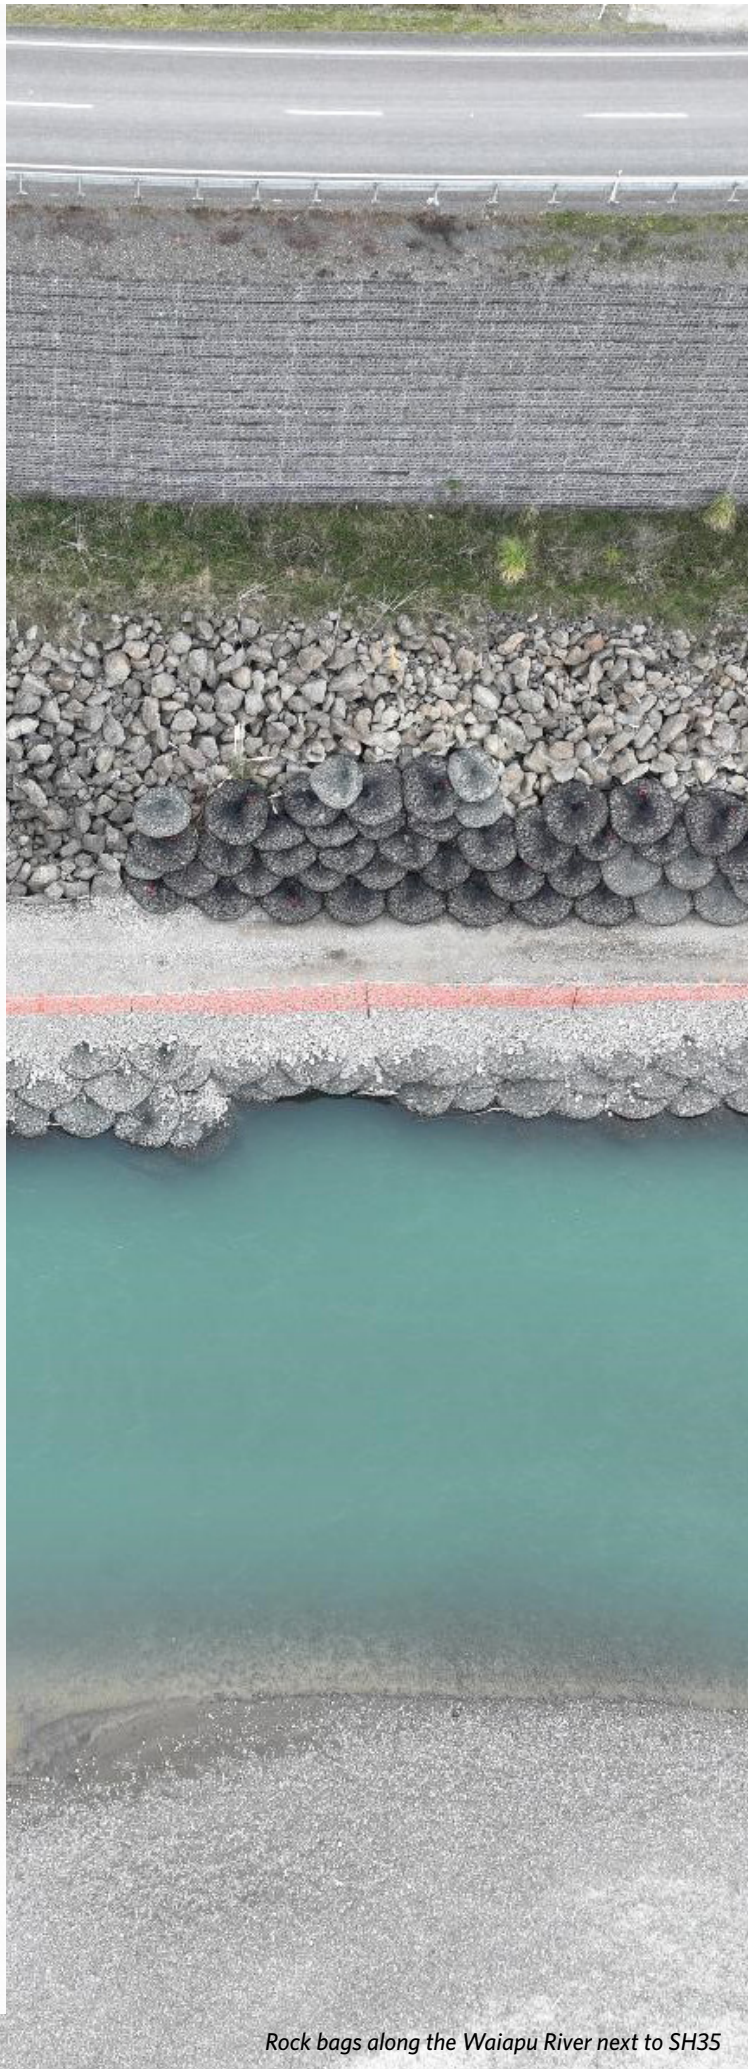
Rock bags along the Waiapu River next to SH35

The rock bags also offer a sustainable environmental advantage as the spaces between the rocks provide a habitat for plant life and become an adopted home for fish and other aquatic life. They also support natural vegetation and encourage the development of local flora.

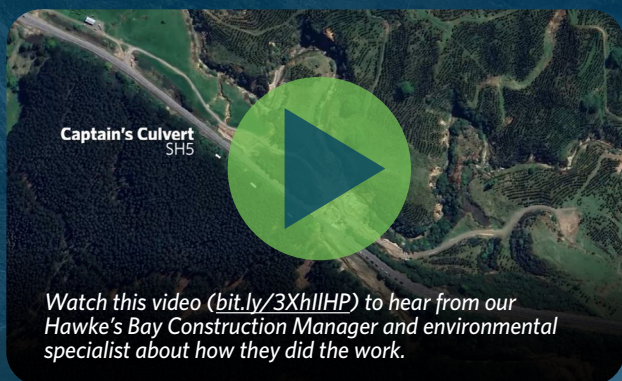
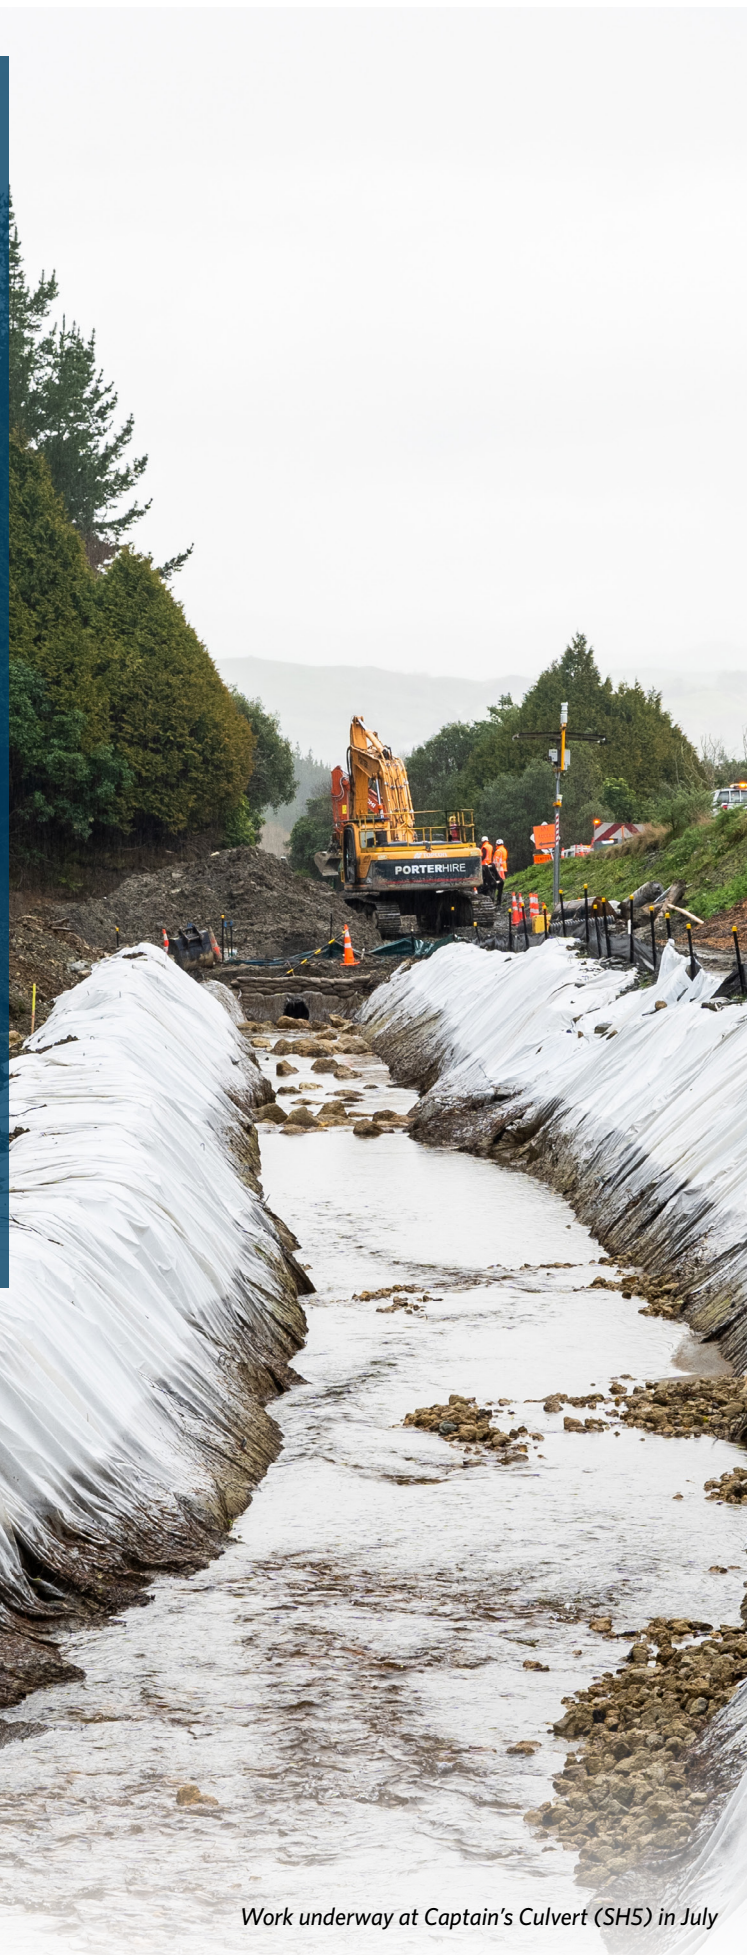
Work underway at Captain's Culvert (SH5) in July

Work at Captain's Culvert, on SH5 between Taupō and Hawke's Bay, is nearing completion. The culvert was significantly clogged with debris and silt following Cyclone Gabrielle. A clogged culvert can push water onto the road potentially damaging it leading to a closure.

To slow and direct water through the culvert the team working on site cleared the culvert and installed large rocks (riprap) and gabion baskets (baskets filled with rocks) to protect the culvert and the sides of the river from damage during heavy water flow.

For the work to be done, the crew also diverted the stream to protect marine life. The stream has been reinstated to its natural route.

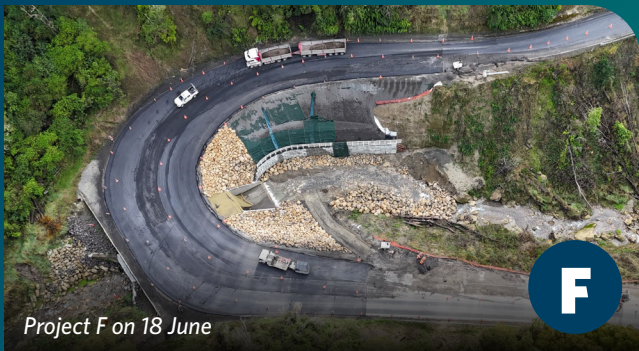
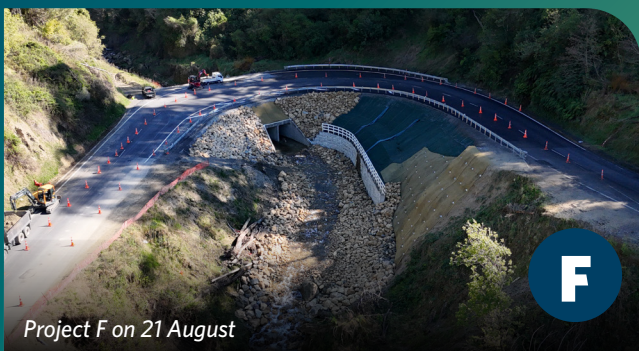
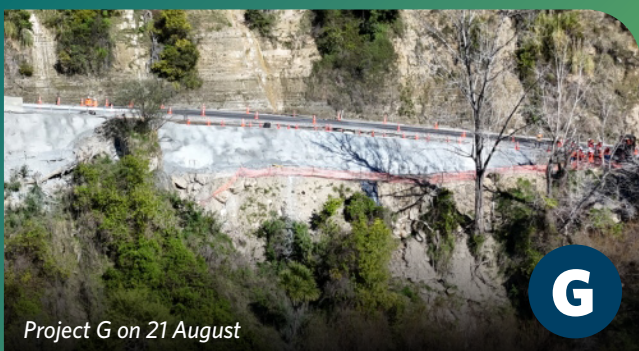
Devil's Elbow suffered massive damage and much of this section of road is still down to one lane, causing ongoing disruptions.

Our focus has been on repairing the road and building in some added resilience. Work on multiple sites has involved debris removal, stabilisation, rock scaling, stormwater upgrades and road repairs. The team also regularly monitor the highway and carry out maintenance to keep this route open.

On the map above, we're currently working at Projects D, K, F and G. These include a large amount of ground anchoring to help secure the hillside. We're nearing completion at Project F, the large culvert and embankment in the hairpin section of the road. We will start Projects O and P next.

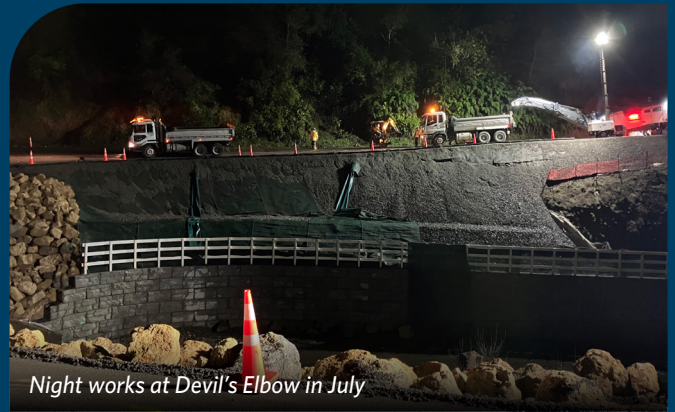
Night works at Devil's Elbow in July

In mid July we closed State Highway 2 between Pan Pac, Whirinaki (north of Napier) and Tūtira for three nights, so crews could work safely and make great progress on several sites at once.

- Blast several large rocks to remove them from the slope at Waikoau Hill.
- Complete most asphaltting for the new road surface (rain hampered the final section, which was completed later that week under stop/go).
- Install two of four stormwater catchments at Tangoio Falls.

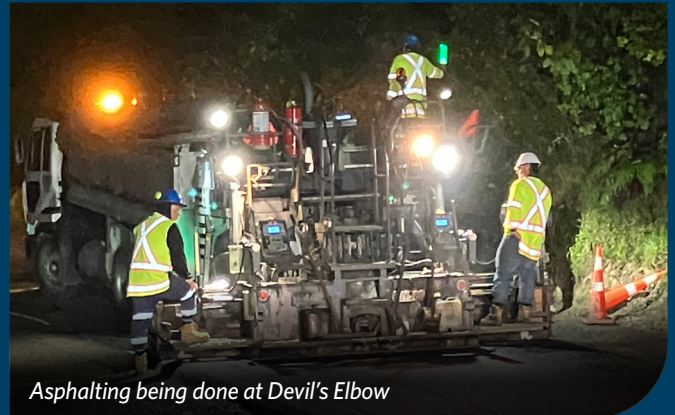
Asphaltting being done at Devil's Elbow

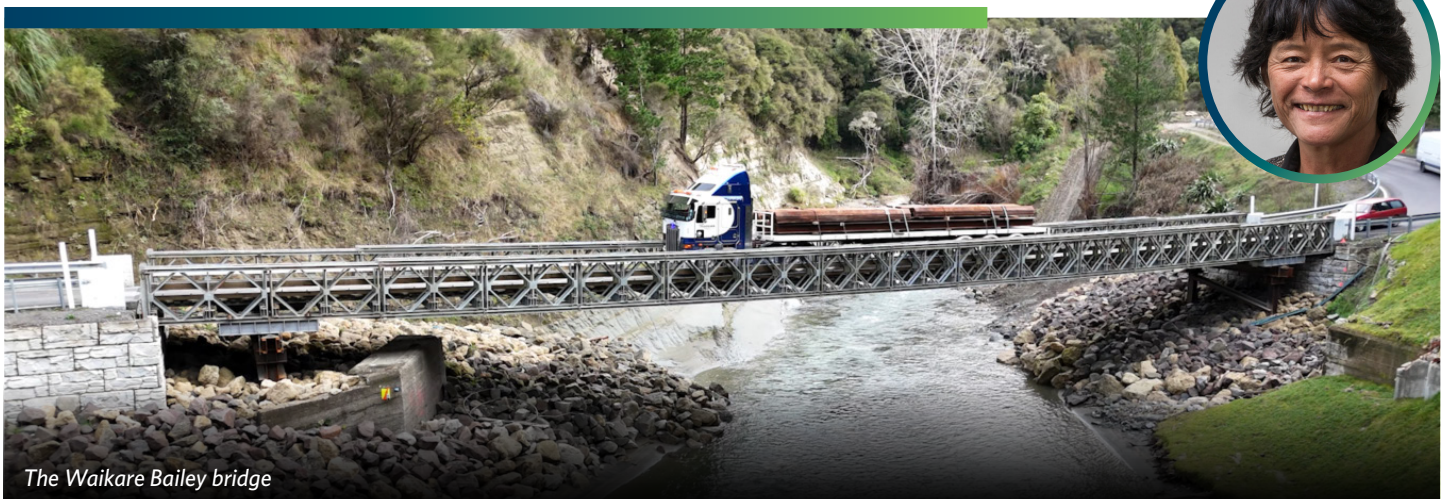
The Waikare Bailey bridge

After Cyclone Gabrielle she provided inputs on the temporary Bailey bridges designed, built, and put in at Hikuwai and in Waikare Gorge.

"Developed in World War II Bailey bridges have shown their resilience as a good temporary option," Rhonda says.

"For Waikare Gorge we had to consider the tortuous alignment for constructing it and for long trucks negotiating the curves. We ended up with what might be the longest span ever done for a Bailey bridge in New Zealand.

This kept the piers out of the water, which we needed to do to avoid it being washed away by any further debris."

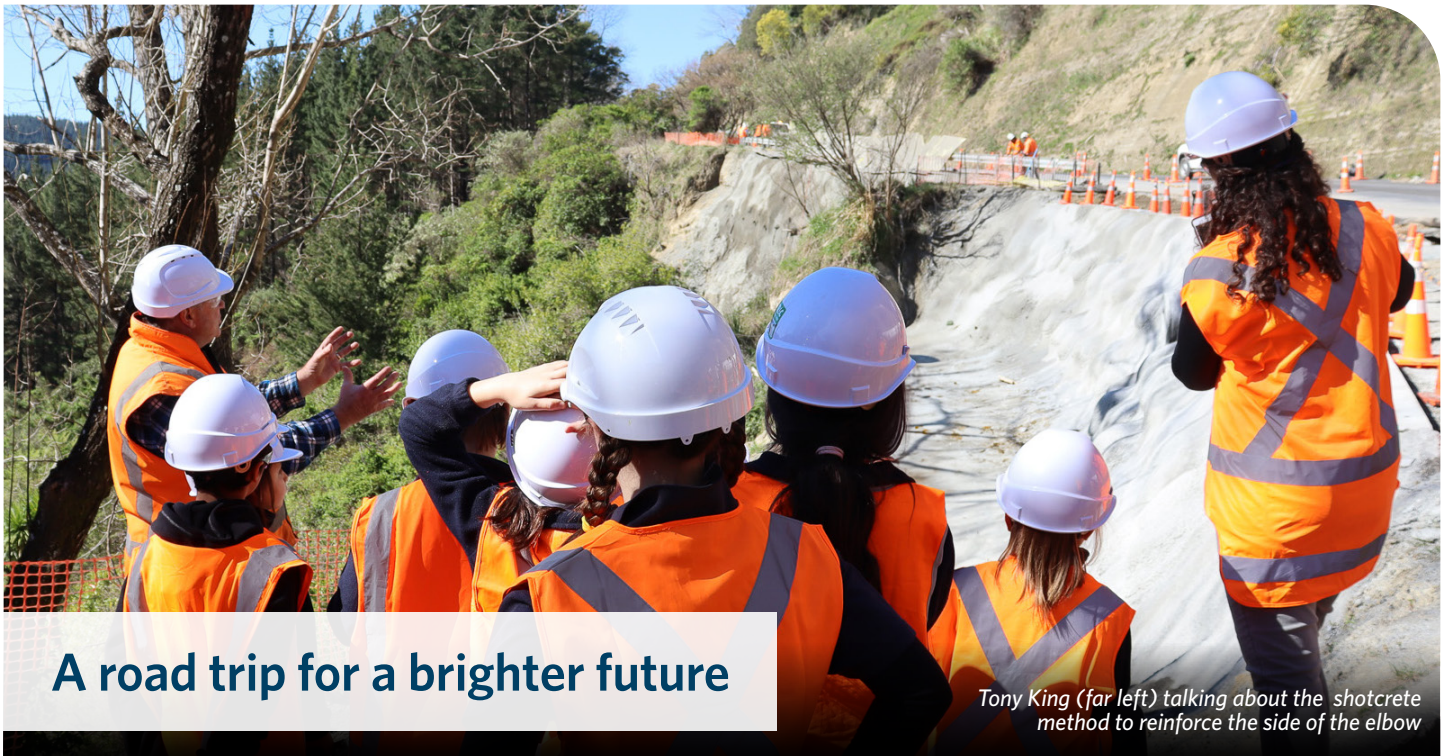
*Tony King (far left) talking about the shotcrete method to reinforce the side of the elbow*

Students were able to walk along the road getting commentary on the techniques used to repair and strengthen Devil’s Elbow. It was an opportunity to showcase engineering, construction, science, and traffic management in action.

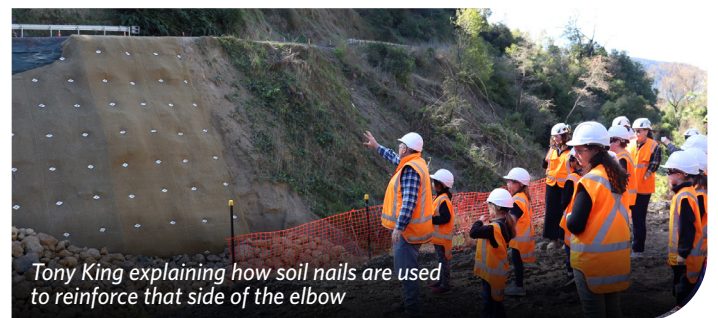
*Tony King explaining how soil nails are used to reinforce that side of the elbow*
