# Protecting our environment

## Minimising environmental impact has been a key focus for the Western Belfast Bypass project team.

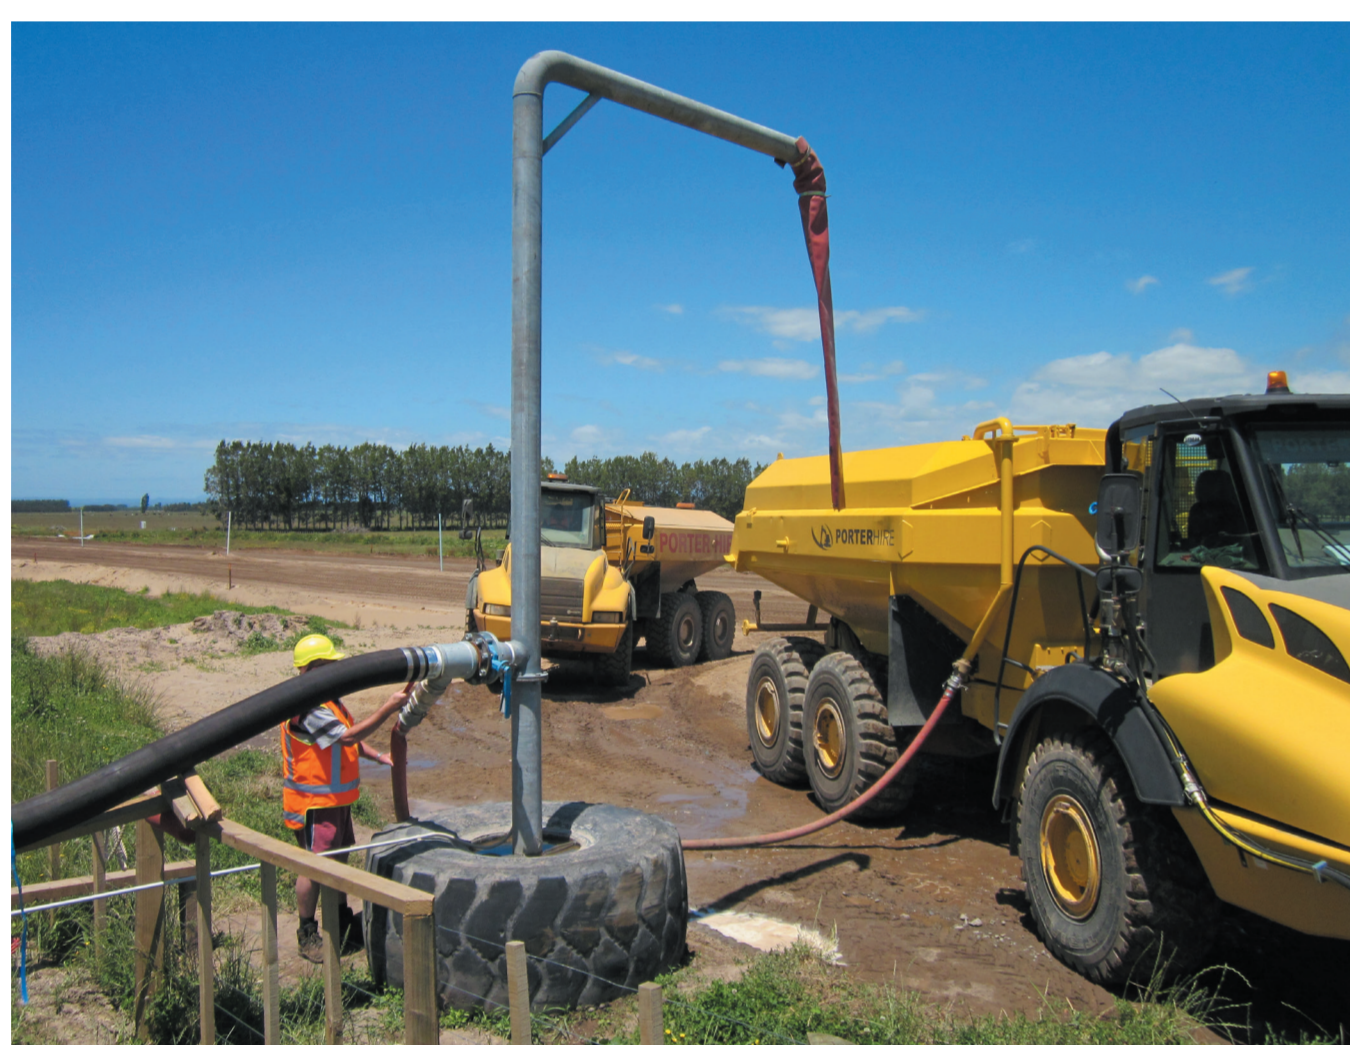
Water truck fill station

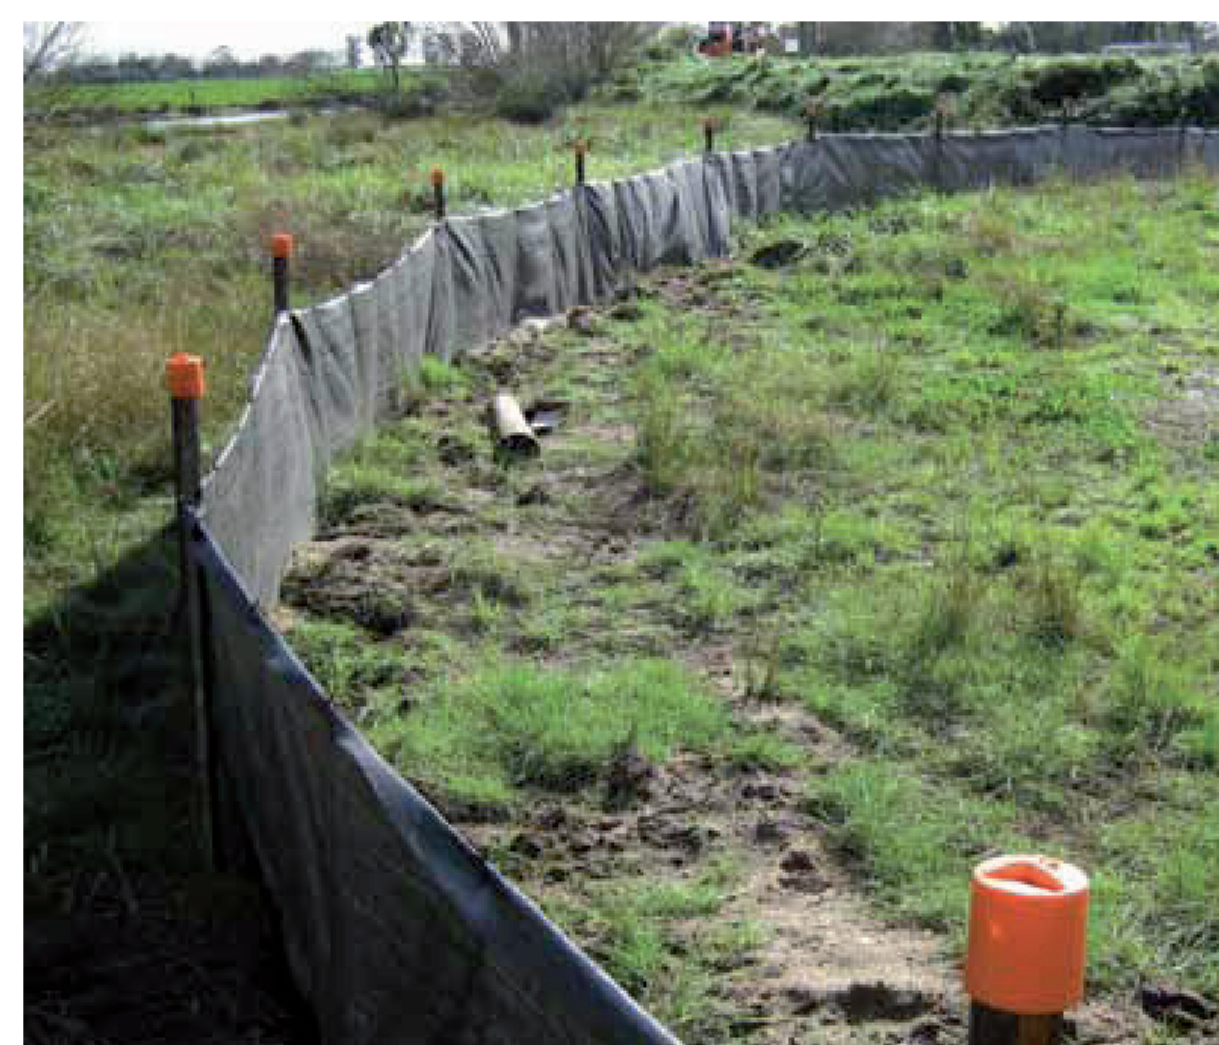
Silt fences are used to limit silt from entering the surrounding waterways

Various types and sizes of sediment control systems were used, depending on the catchment area including containment and perimeter bunds, soaking ponds, silt fences and stabilised access ways.

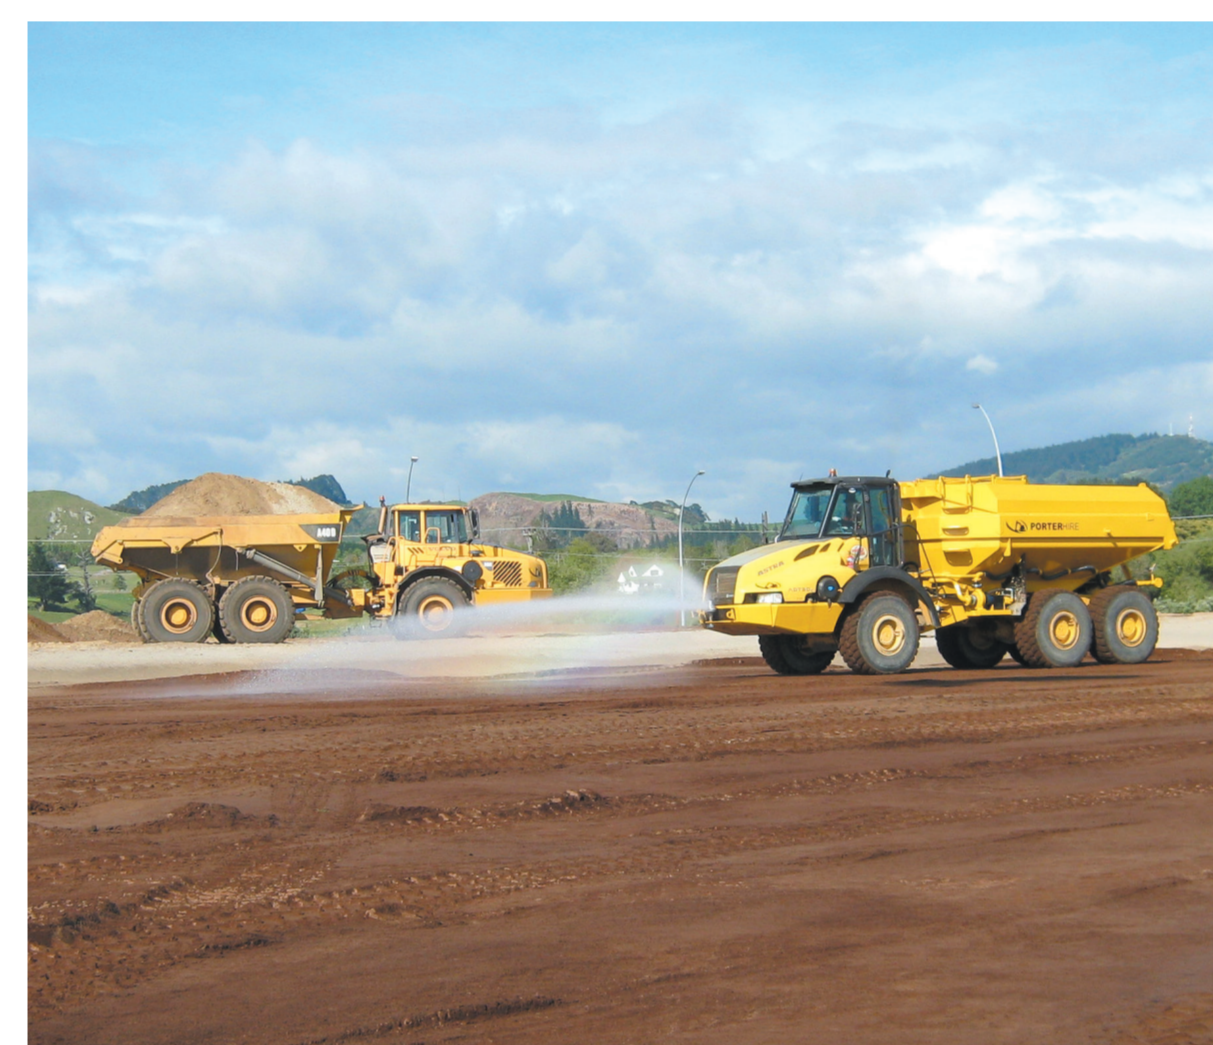
Water carts watering exposed ground

- the ground was watered using water carts
- irrigation systems were installed in some areas
- dust prevention layers such as aggregate, mulch or hydro-seeding (grass), and dust suppressants were used.

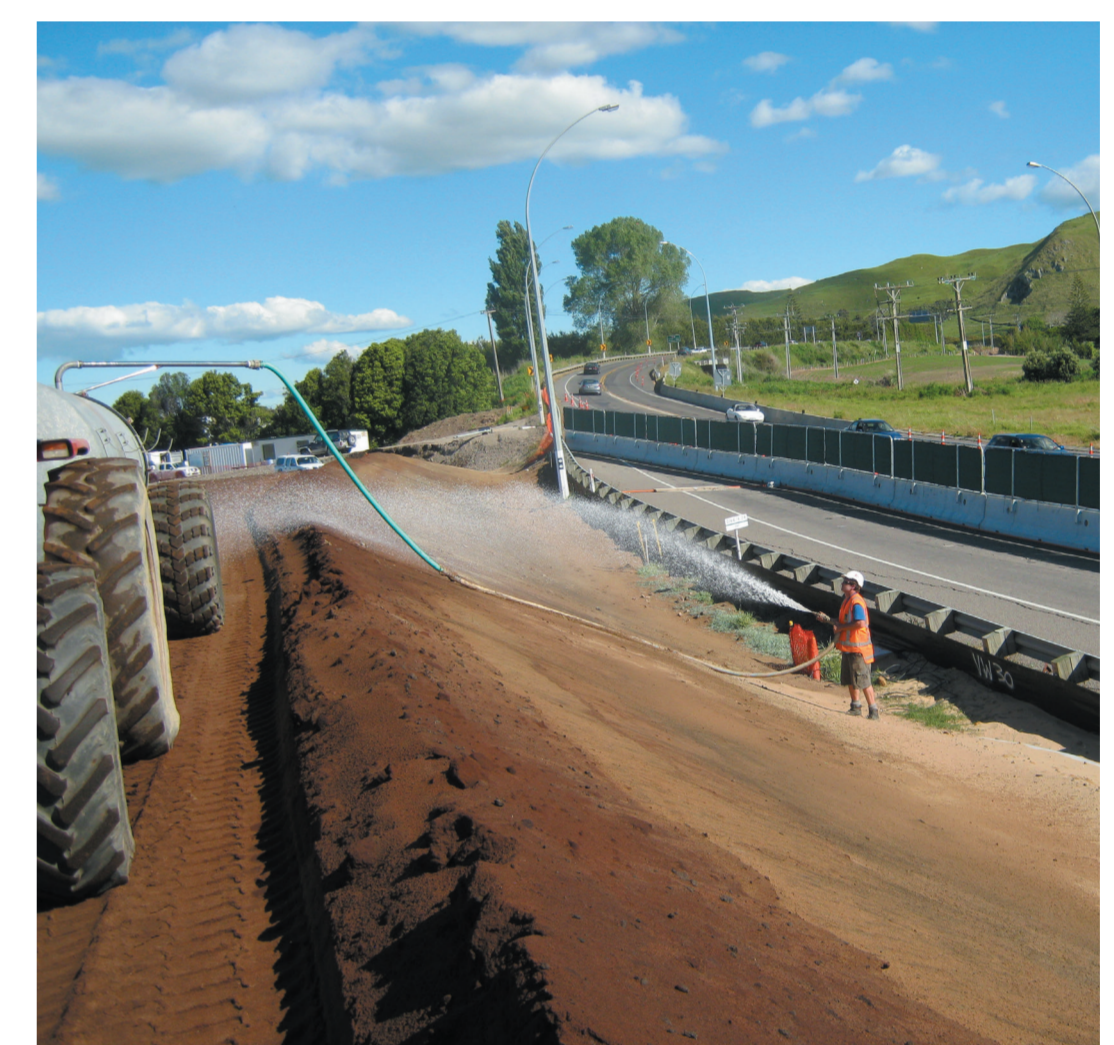
A dust suppressant is sprayed on to exposed dirt and sand, as it dries it forms a crust

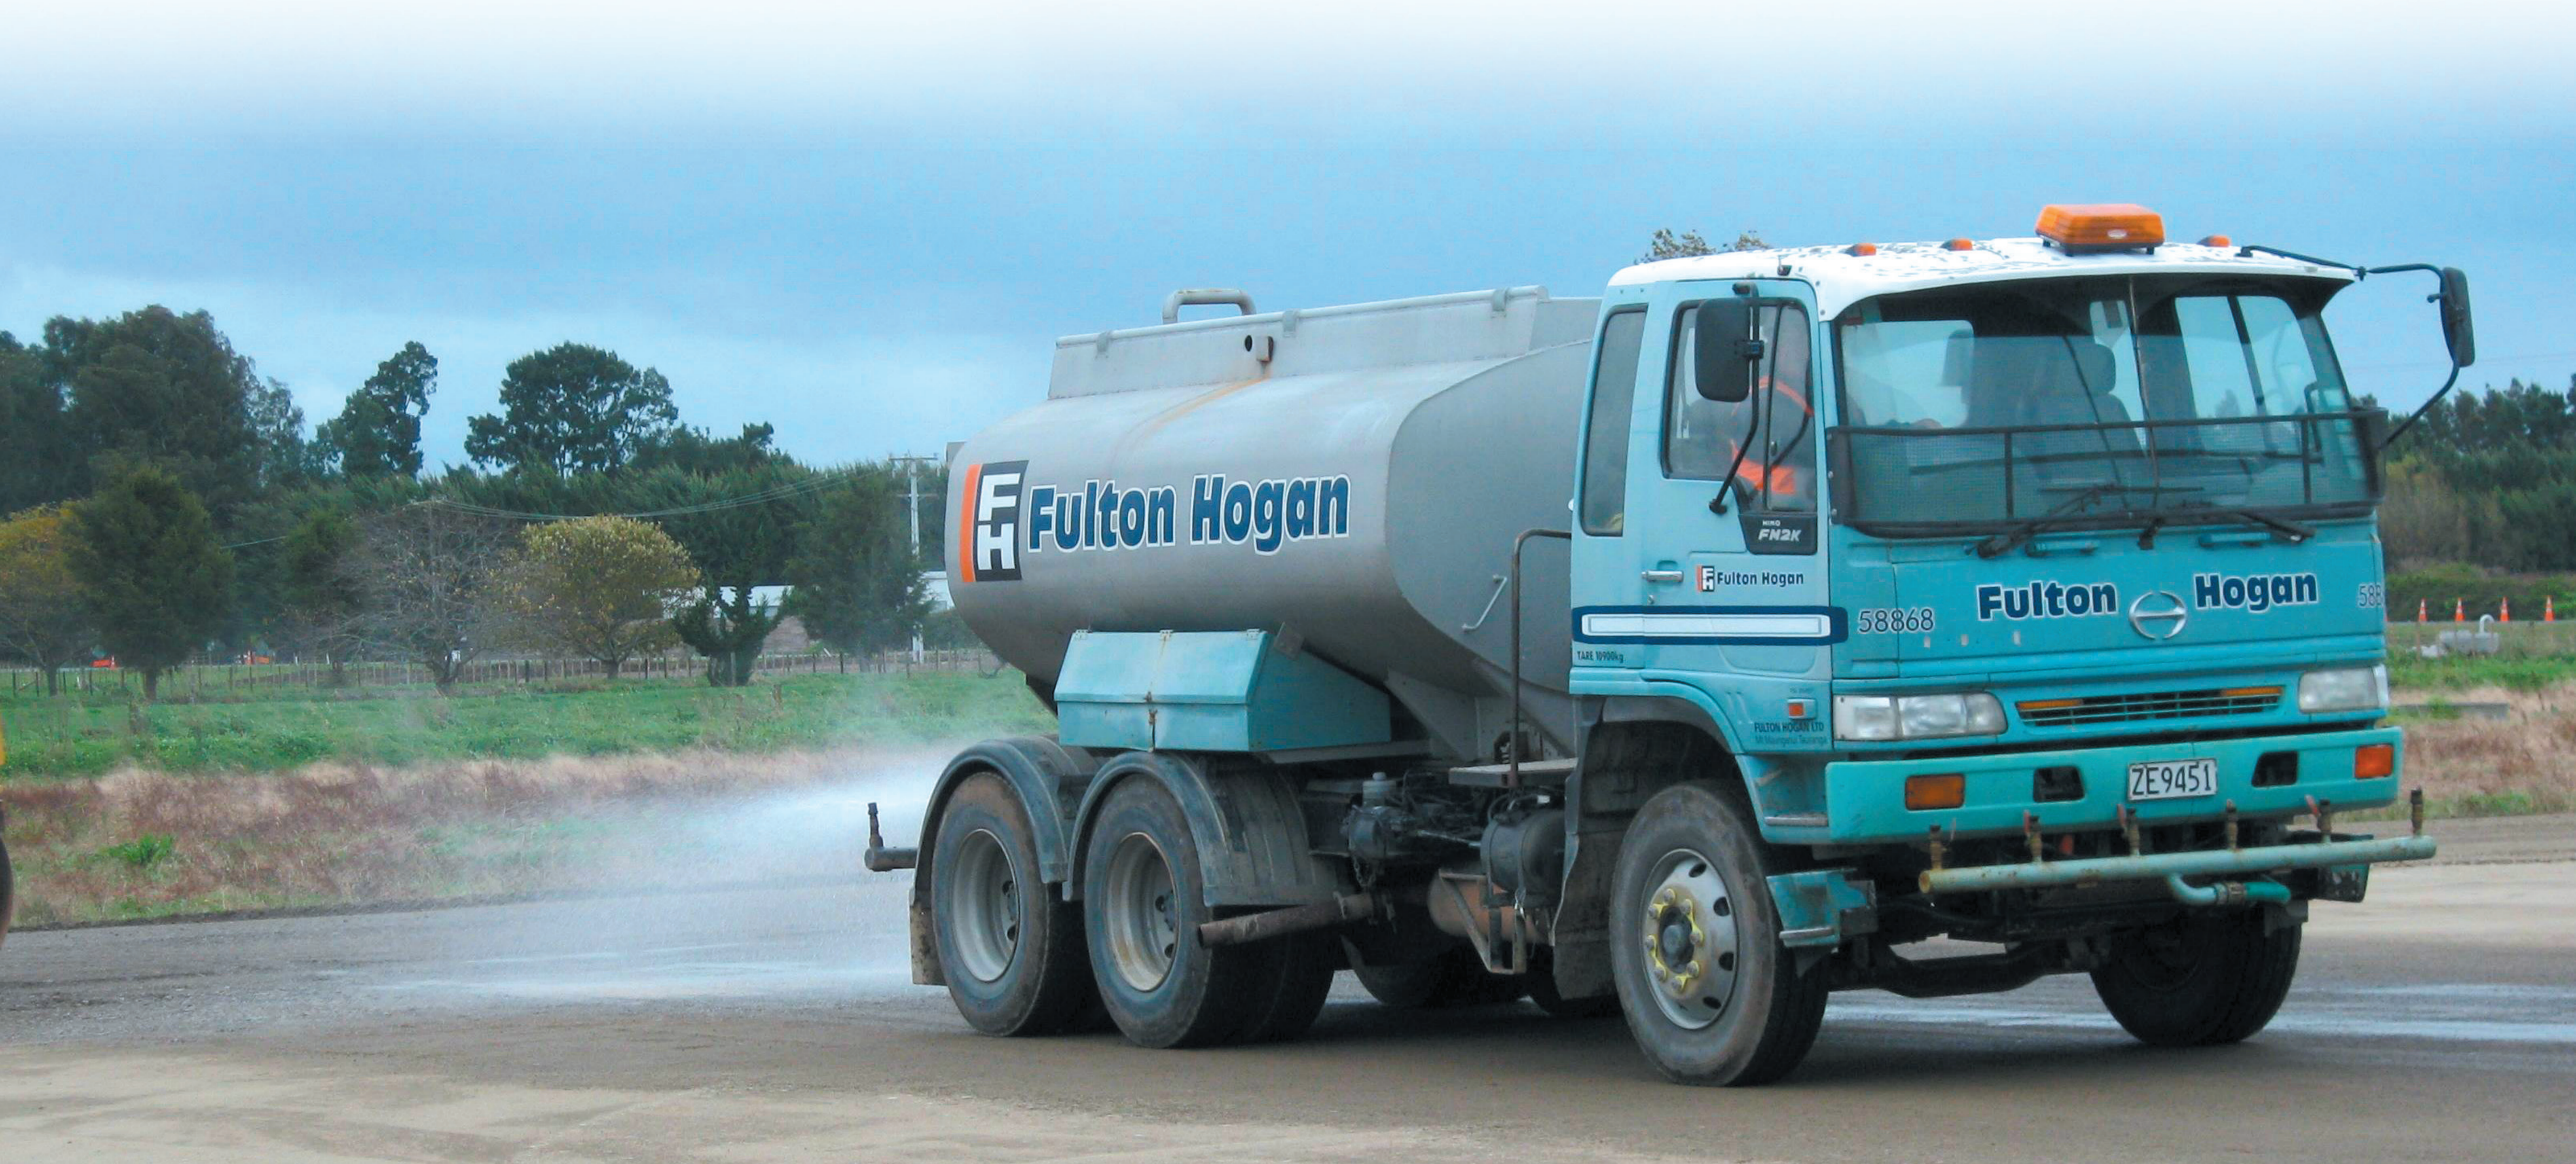
Water truck for dust mitigation
