Factors influencing the decision to rehabilitate a pavement

June 2012

Patrick, JE and H Aramoorthy (2012) Factors influencing the decision to rehabilitate a pavement. NZ Transport Agency research report 491. 108pp.

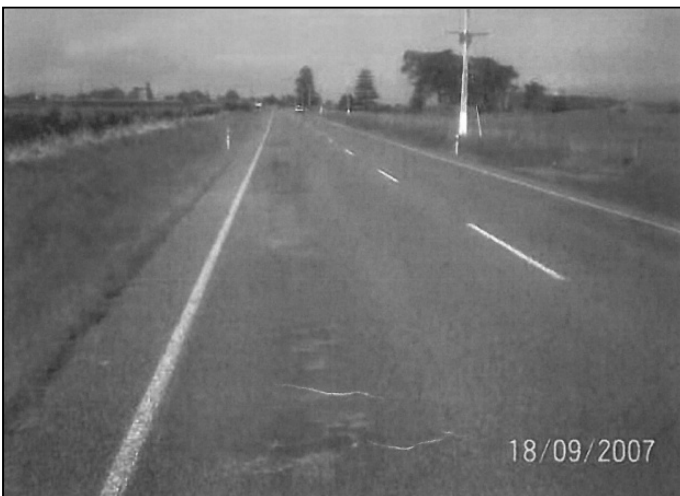
Site 2 is located in a rural environment with an approximate AADT of 9000vpd. The road was constructed in 1959 and had a 70mm overlay in 1998. This site had a small amount of rutting, with no shoving, and a minimal amount of flushing. The site had a small number of relatively old looking patch repairs; however, these were generally in good condition (figures 4.1 and 4.2). The shoulders and drainage were good and the ride quality through the site was very good. This site did not appear to require an area-wide treatment.

Figure 4.2 Alternate view of site 2, facing the opposite direction

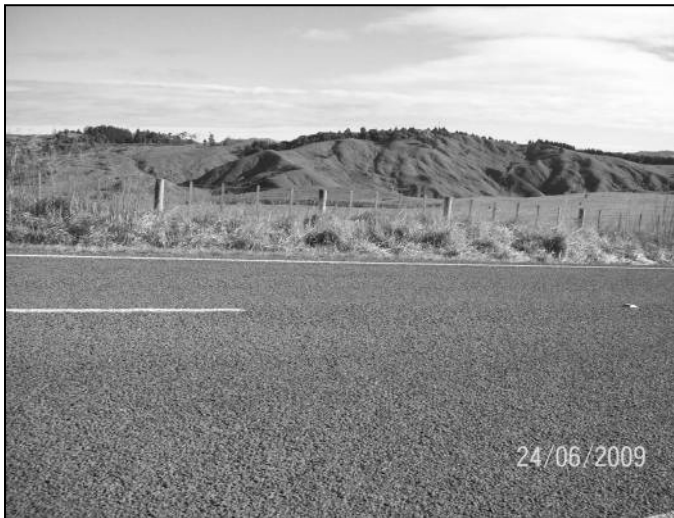
Figure 4.8 Alternate view of site B3

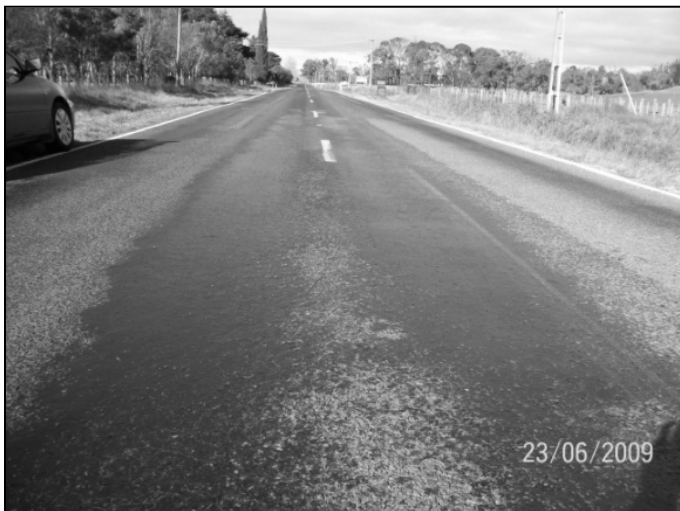
The engineer suggested that this location possibly had drainage issues - note the high shoulders visible in figures 4.27 and 4.28.

Figure 4.27 View of site C3, showing flushing and the high road shoulders

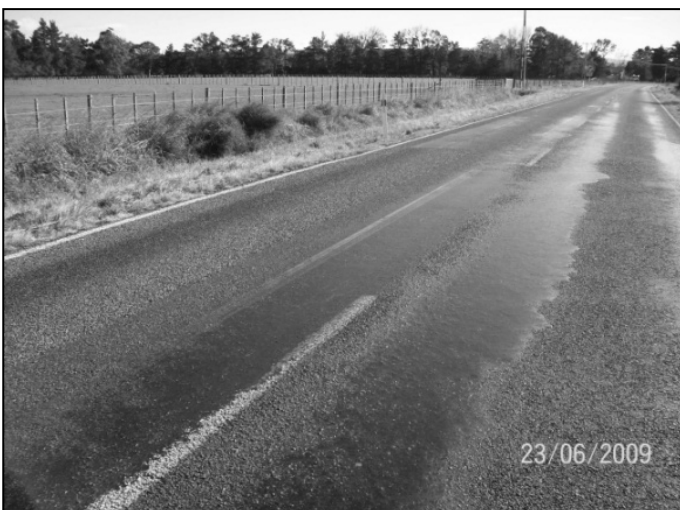
Figure 4.28 View of site C3, showing the high shoulders and an area of extensive flushing

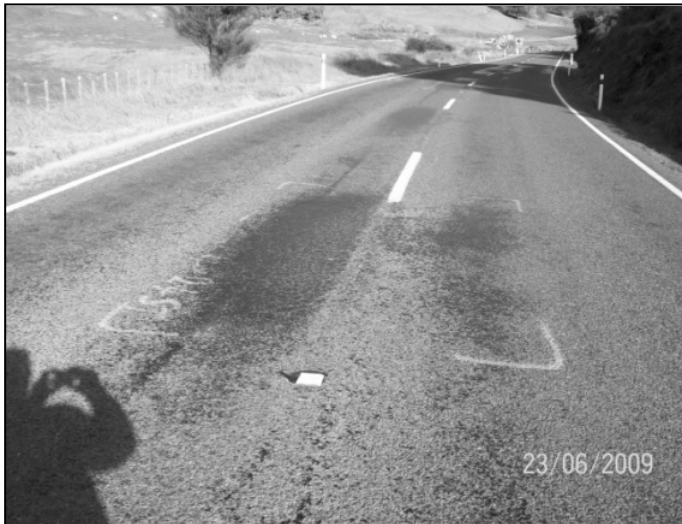
Figure 4.36 View of site C8, showing flushing

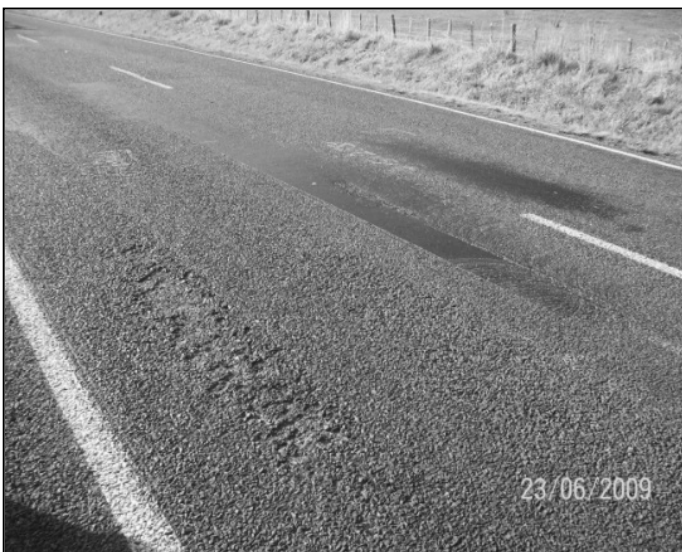
Figure 4.37 View of site C8, showing chip loss and flushing

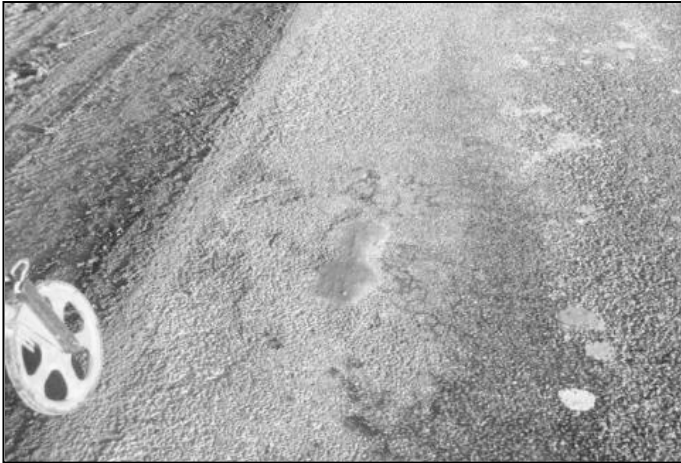
Figure 4.63 Second close-up view of site D6, showing flushing

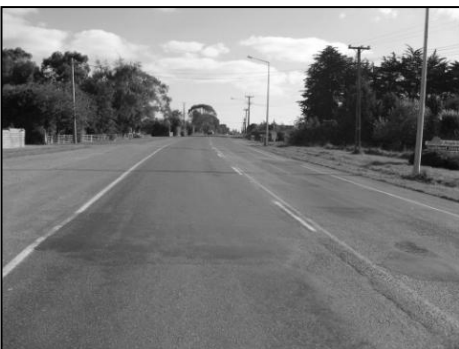
- increasing maintenance and associated costs
- repair failures
- wheeltrack rutting and flushing.

Figure 4.72 View of site D11, showing repair failures and flushing

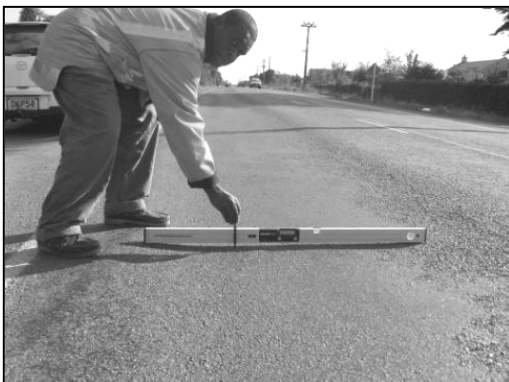
Figure 4.73 Alternative view of site D11, showing the depth of rutting

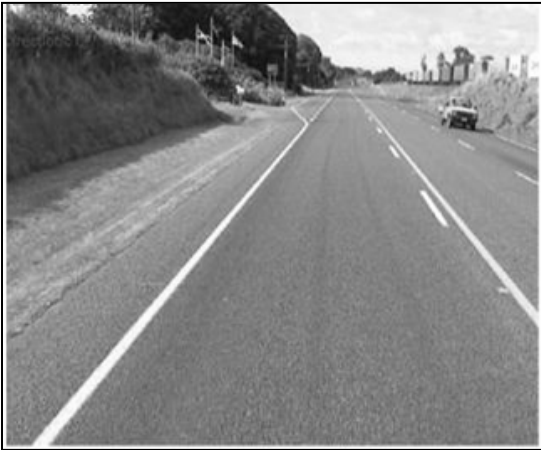
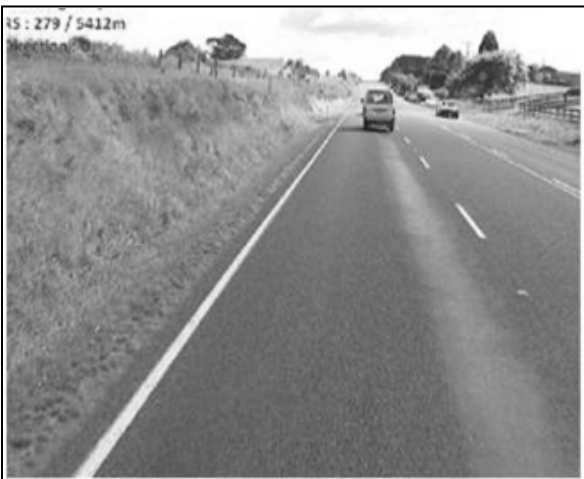
The second inspection length (inspection length 2) for site A1 was 279/5380–5421 (figures 5.8 and 5.9).

Figure 5.8 Inspection length 2 for site A1: RP 279/5391 increasing

Figure 5.9 Inspection length 2 for site A1: RP 279/5411 decreasing

The inspection section **does not** represent the full rehabilitation section very well.

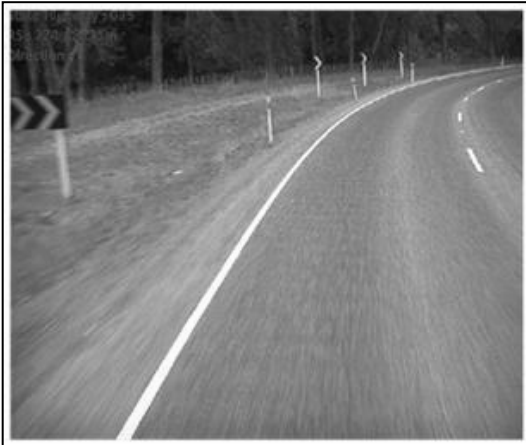
Figure 5.13 Typical view of the inspection length in site B2 (RP 8721), showing evidence of pavement distress

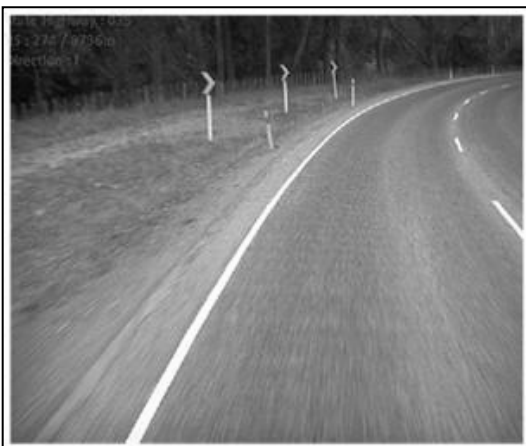
Figure 5.14 Typical inspection length distress in site B2 (RP 8736), showing evidence of corrugation

The inspection section **closely** reflects the full rehabilitation section.

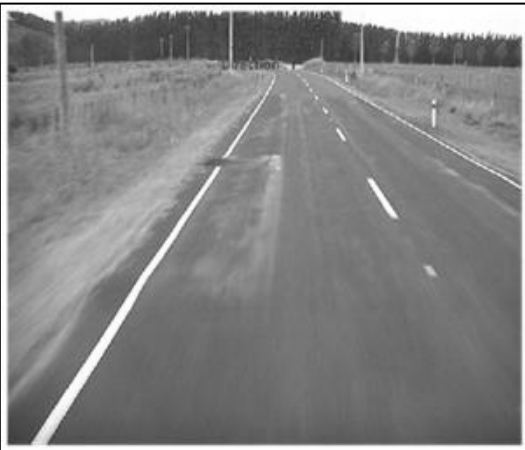
Figure 5.19 RP 4323 increasing in site B6, showing evidence of pavement distress

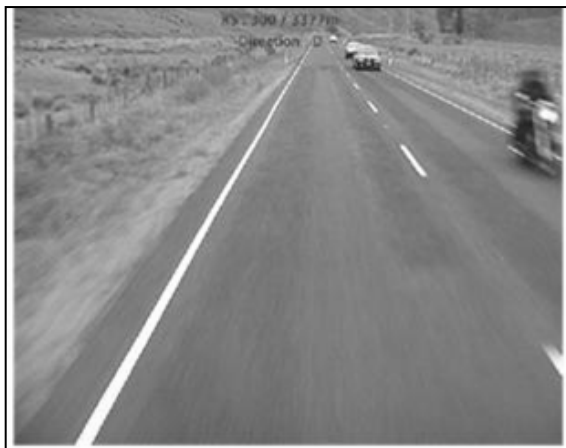
Figure 5.20 Site B6 inspection length 1: RP 3350-3400

Figure 5.21 Inspection length 2: RP 3840-3884

The inspection section **closely** reflects the full rehabilitation section.

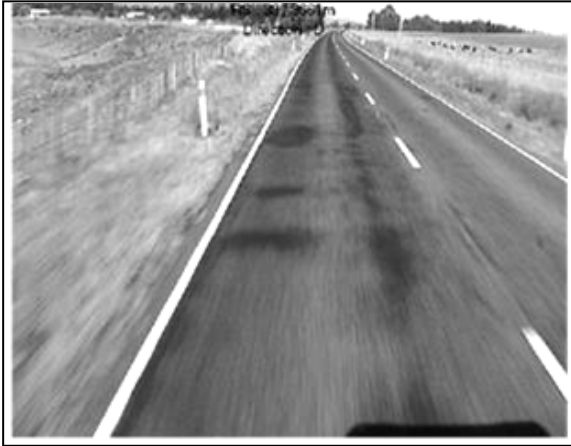
Figure 5.26 Typical view of site C1 (RP 33/3661 decreasing), showing extensive flushing

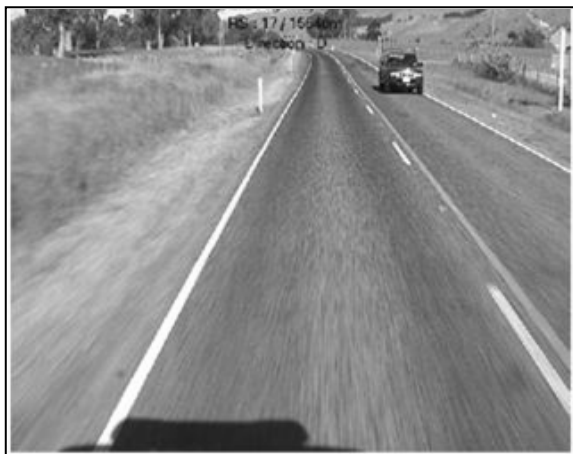
Figure 5.32 Inspection length in site C4: RP 15,533 increasing

Figure 5.33 Inspection length in site C4: RP 15,546 decreasing

The inspection section **closely** reflects the full rehabilitation section.

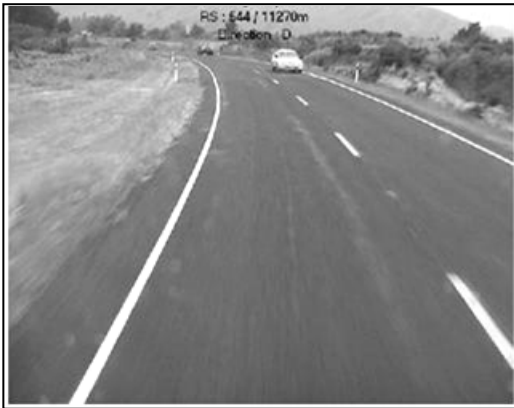
Figure 5.37 Inspection length in site C10: RP 444/11,270 decreasing

Figure 5.38 Inspection length in site C10: RP 544/11,273 increasing

The inspection section **closely** reflects the full rehabilitation section.

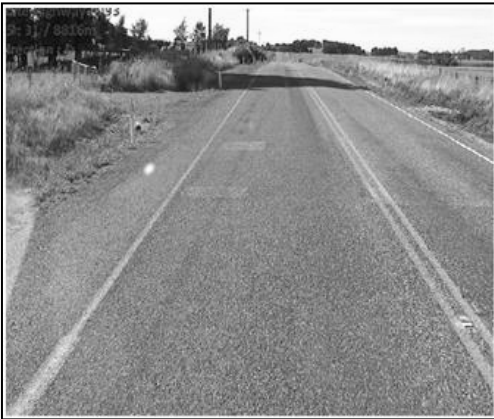
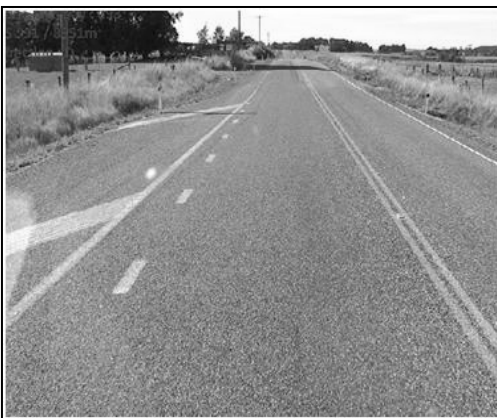
Figure 5.48 Inspection length 1 from site D6: RP 8052

Figure 5.49 Another view of inspection length 1 from site D6: RP 8082

Figure 5.50 Inspection length 2 from site D6: RP 8814

Figure 5.51 Another view of inspection length 2 from site D6: RP 8849

The inspection section **does not** represent the full rehabilitation section very well.

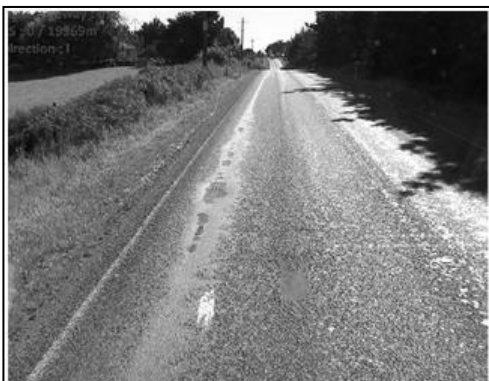
Figure 5.54 Another view of site D10 (RP 0/19,969 increasing), showing generally poor pavement condition

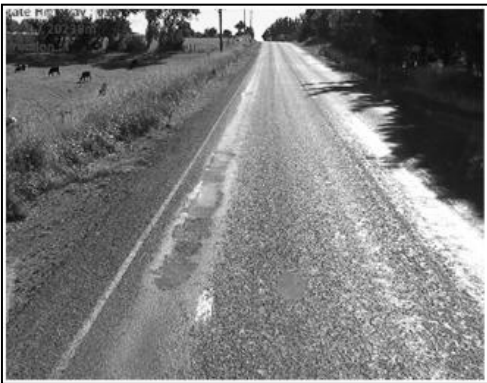
Figure 5.56 Typical section of pavement in site D10 (RP 0/20,234 increasing), showing extensive flushing

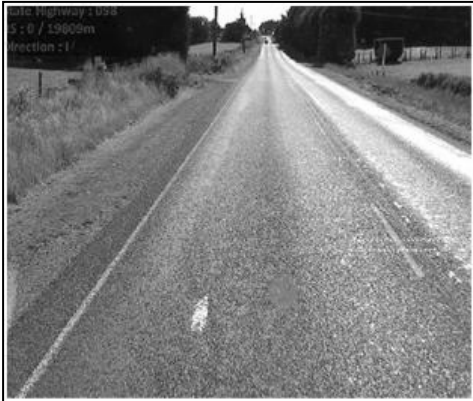
Figure 5.57 View of the inspection in site D10 (RP 0/19,747)

Figure 5.58 Alternate view of the inspection length in site D10 (RP 0/19,807)

The inspection section **does not** correctly reflect the full rehabilitation section.

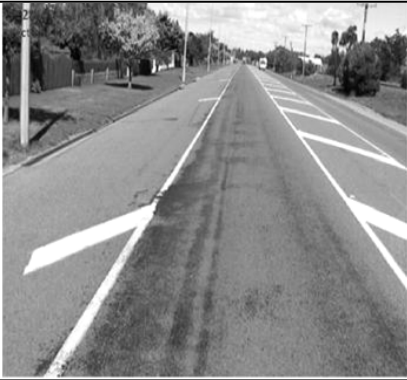
Figure 5.66 Another typical view of site E2 (RP 9452 increasing), showing flushed surface. condition
